# Weather Challenges in Ropeway Operations & Maintenance

Tom Scully-USA  
Risk Control Consultant-Safehold Special Risk  
Tom.scully@safehold.com

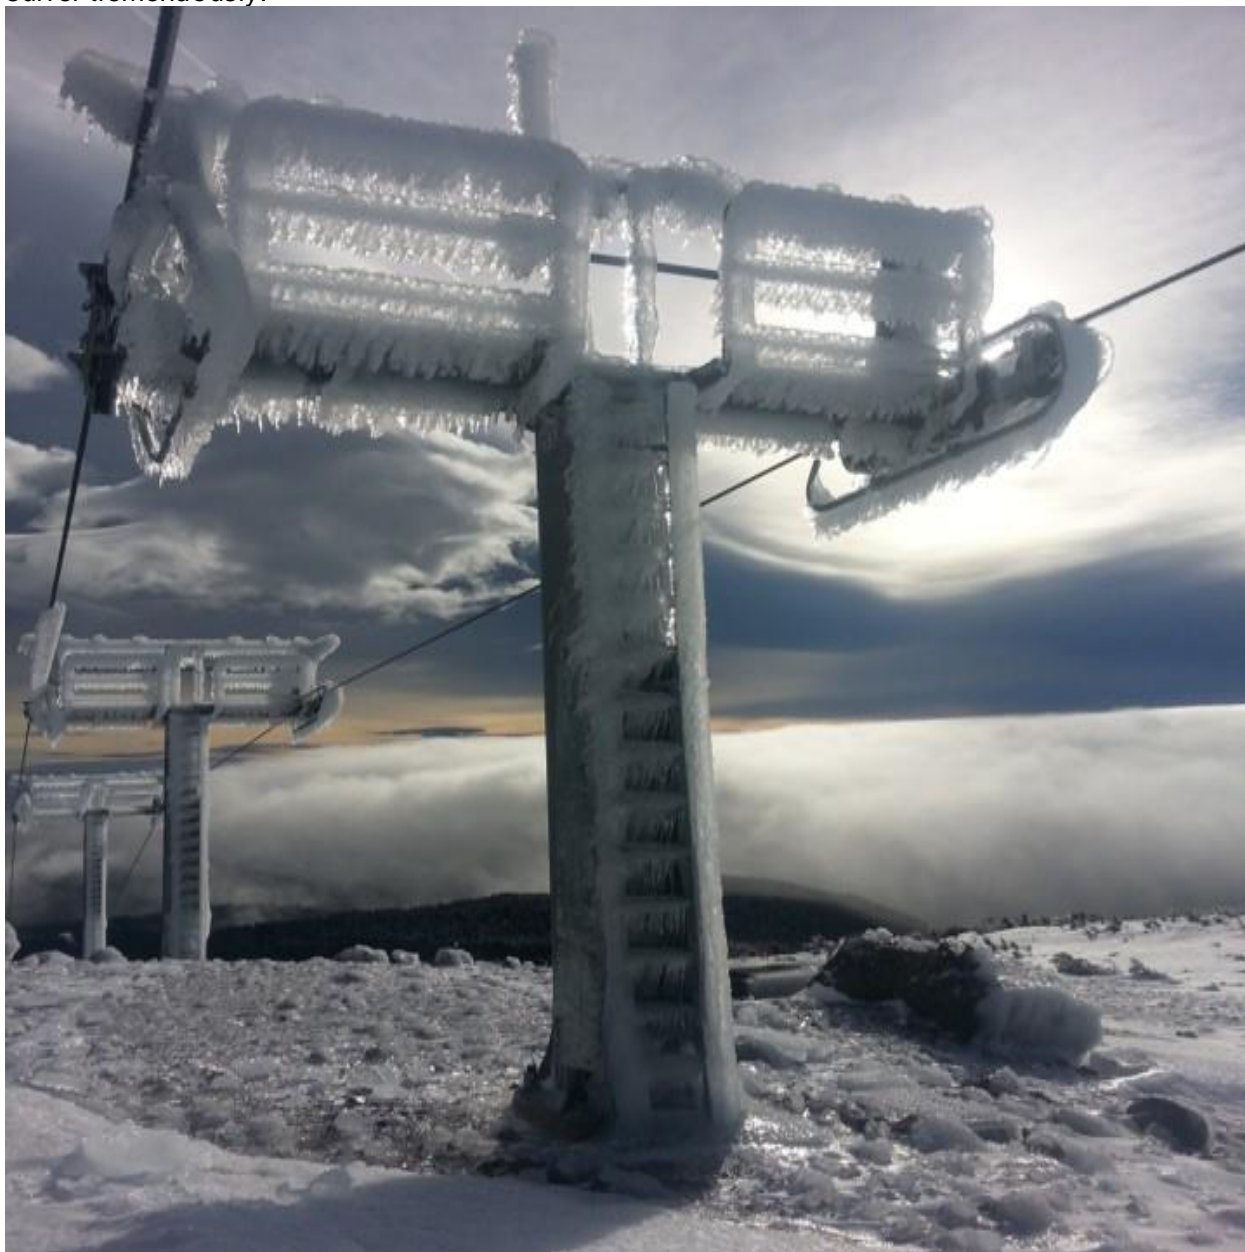
Sometimes the icing or freezing rain changes the snowpack, the skiing and additionally the ski lifts can suffer tremendously.

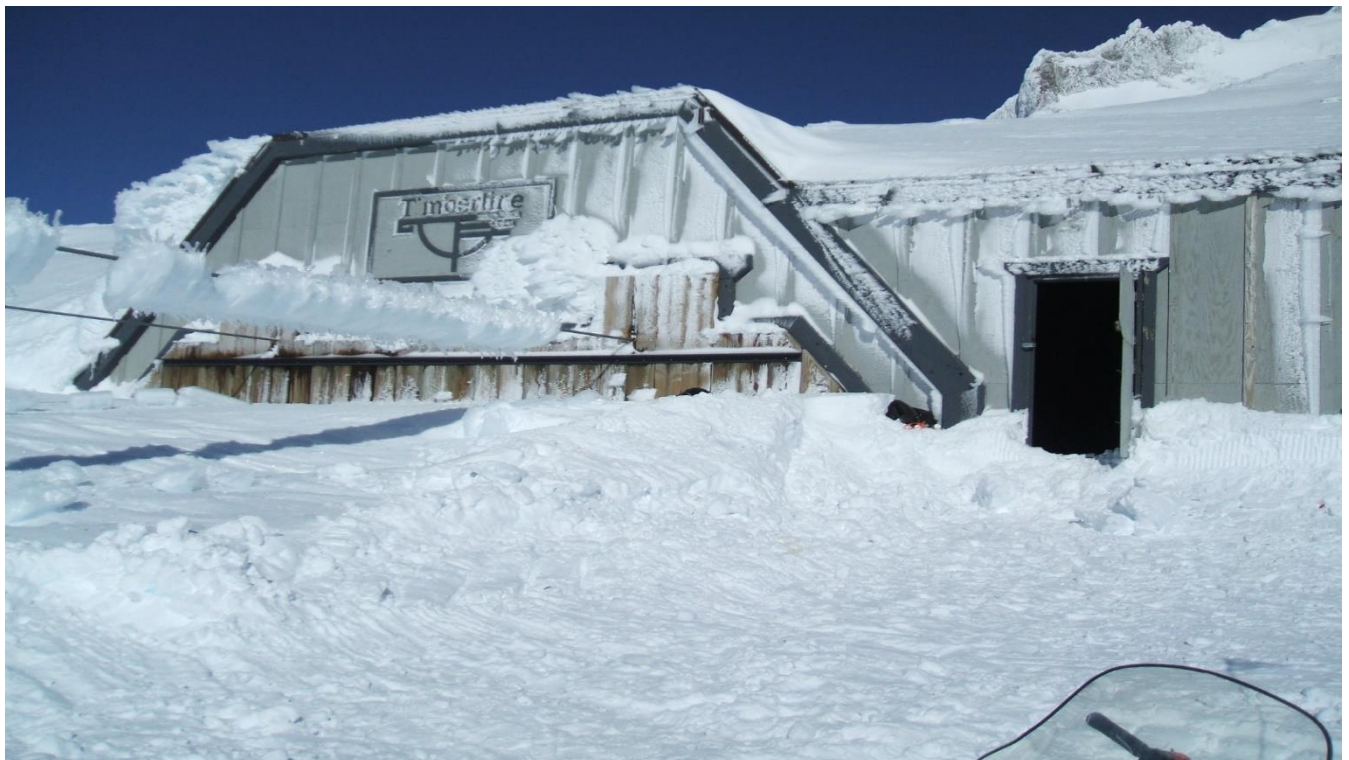
Lift terminals, doors and buildings are under extreme stress and load. Pictured below is the top of Palmer buried with iced up cable (Photo courtesy Rose Phillips)

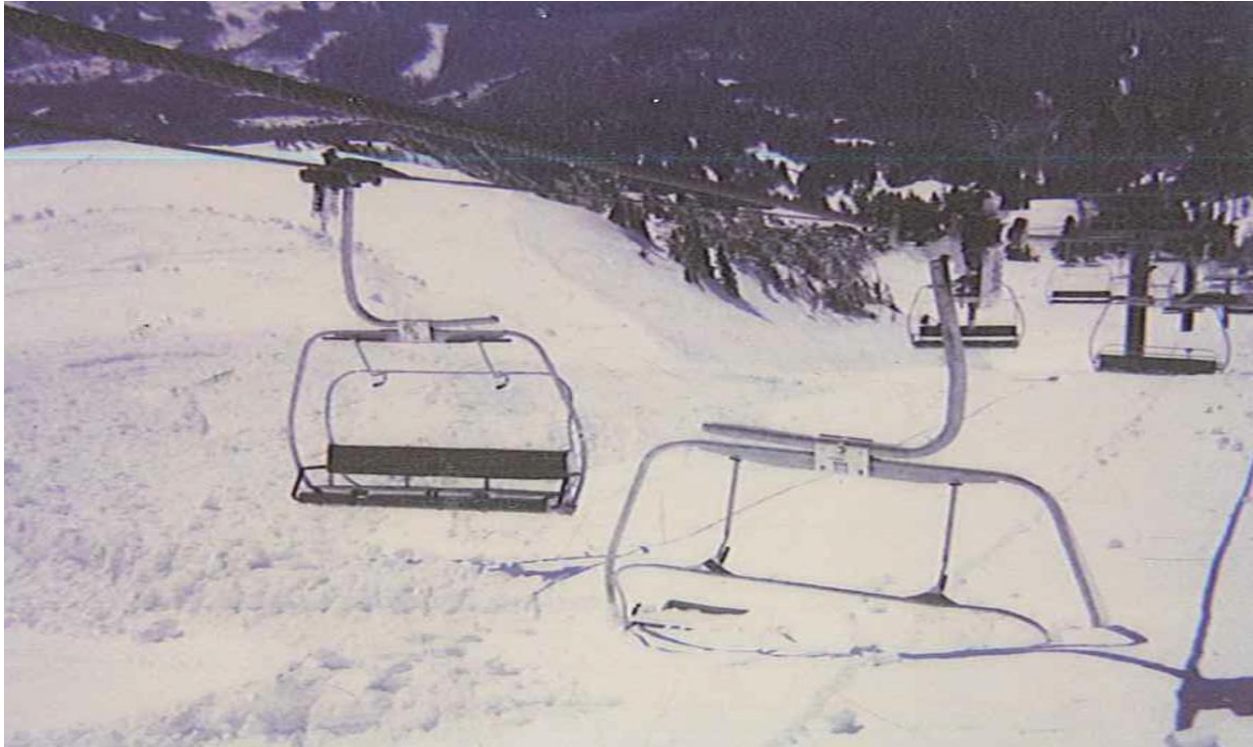
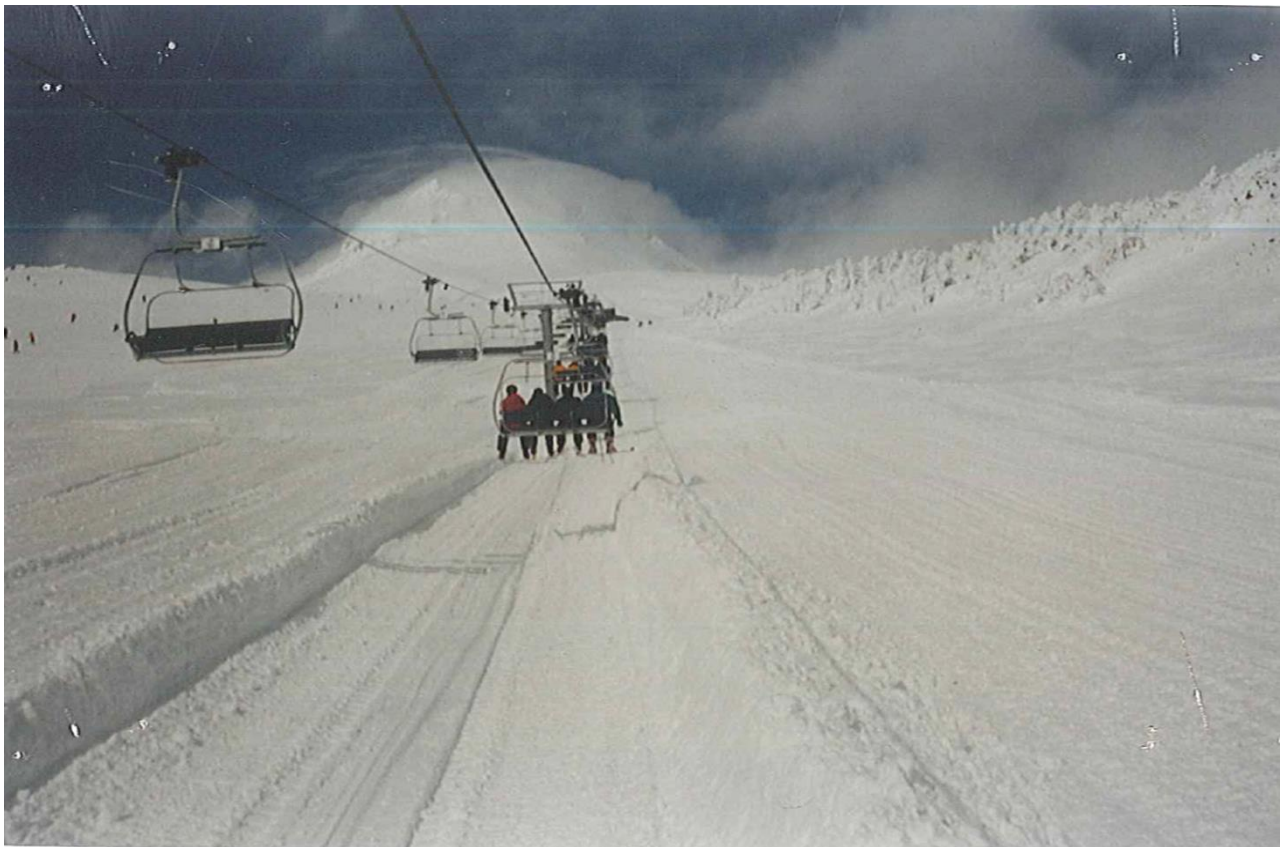
Occasionally snow becomes so deep that lift lines would need to be cleared to operate the lifts.

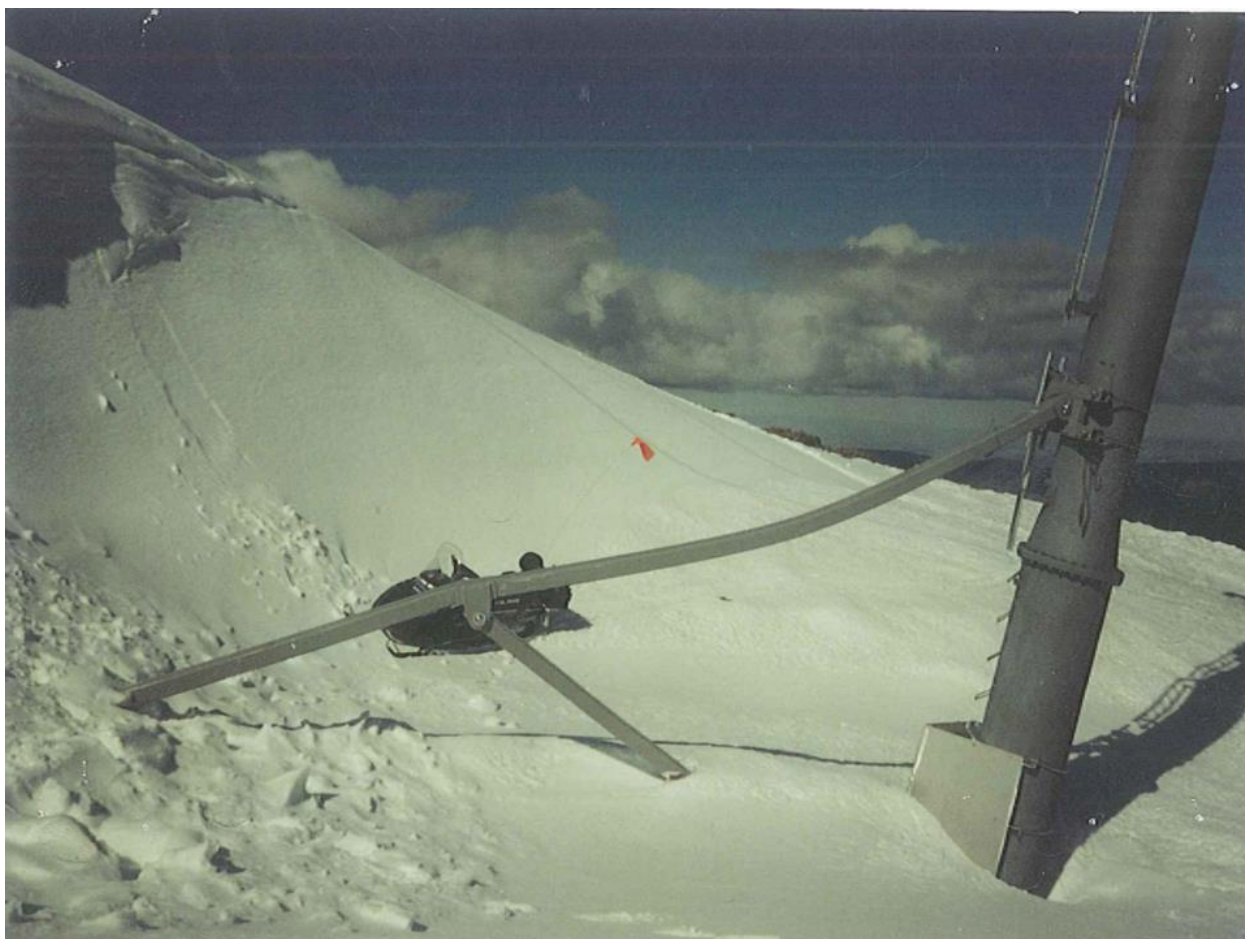
Since many ski area operators in the Northwest observed towers becoming buried under this hefty snowpack, most lifts had some design considerations to help prevent the potential damage. This tower had a creep guard installed on the lowest 20 feet of tower as well as a stiff leg back-stay which was eventually bent under the heavy snowpack. Cables replaced the stiff legs which allowed the cable to slice through the snow better than square steel which added enough surface area and eventually buckled under the weight. Cables are used along with grooved pins which ultimately will shear about the time the cable is completely buried, thus advising the resort personnel that it's time to dig out the tower to relieve the tension of the snow creep or glide.

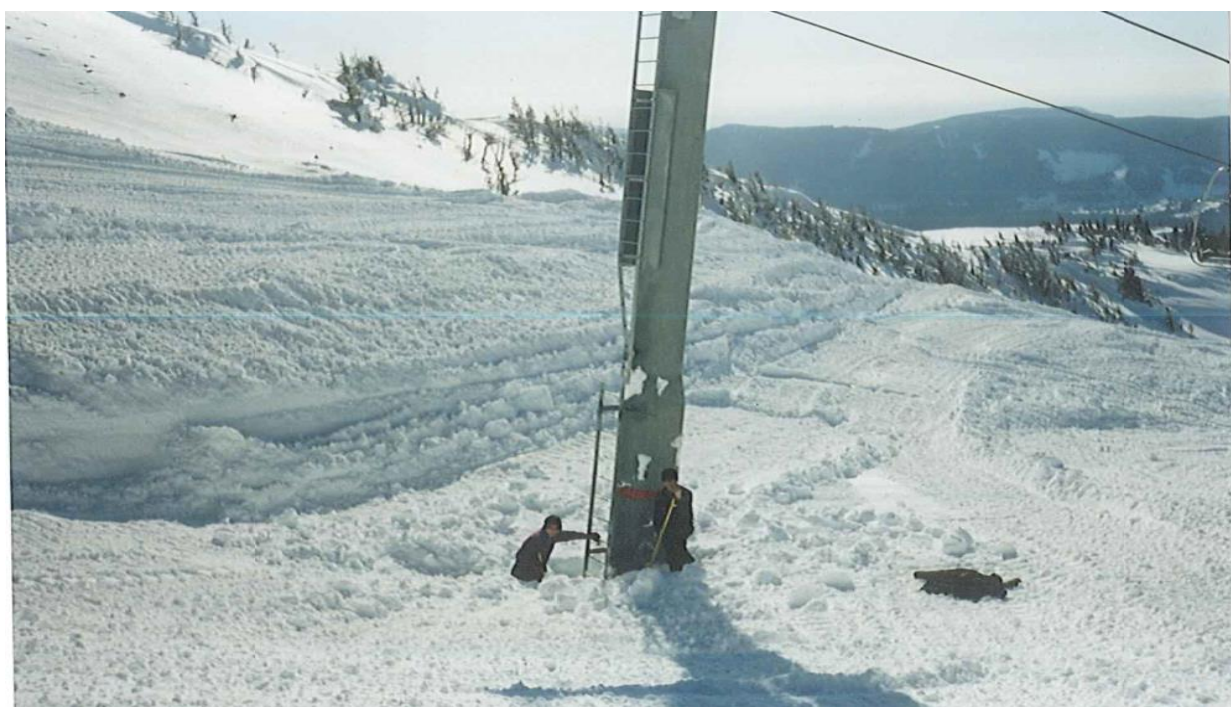
Left untreated, the snow creep will certainly do real damage.

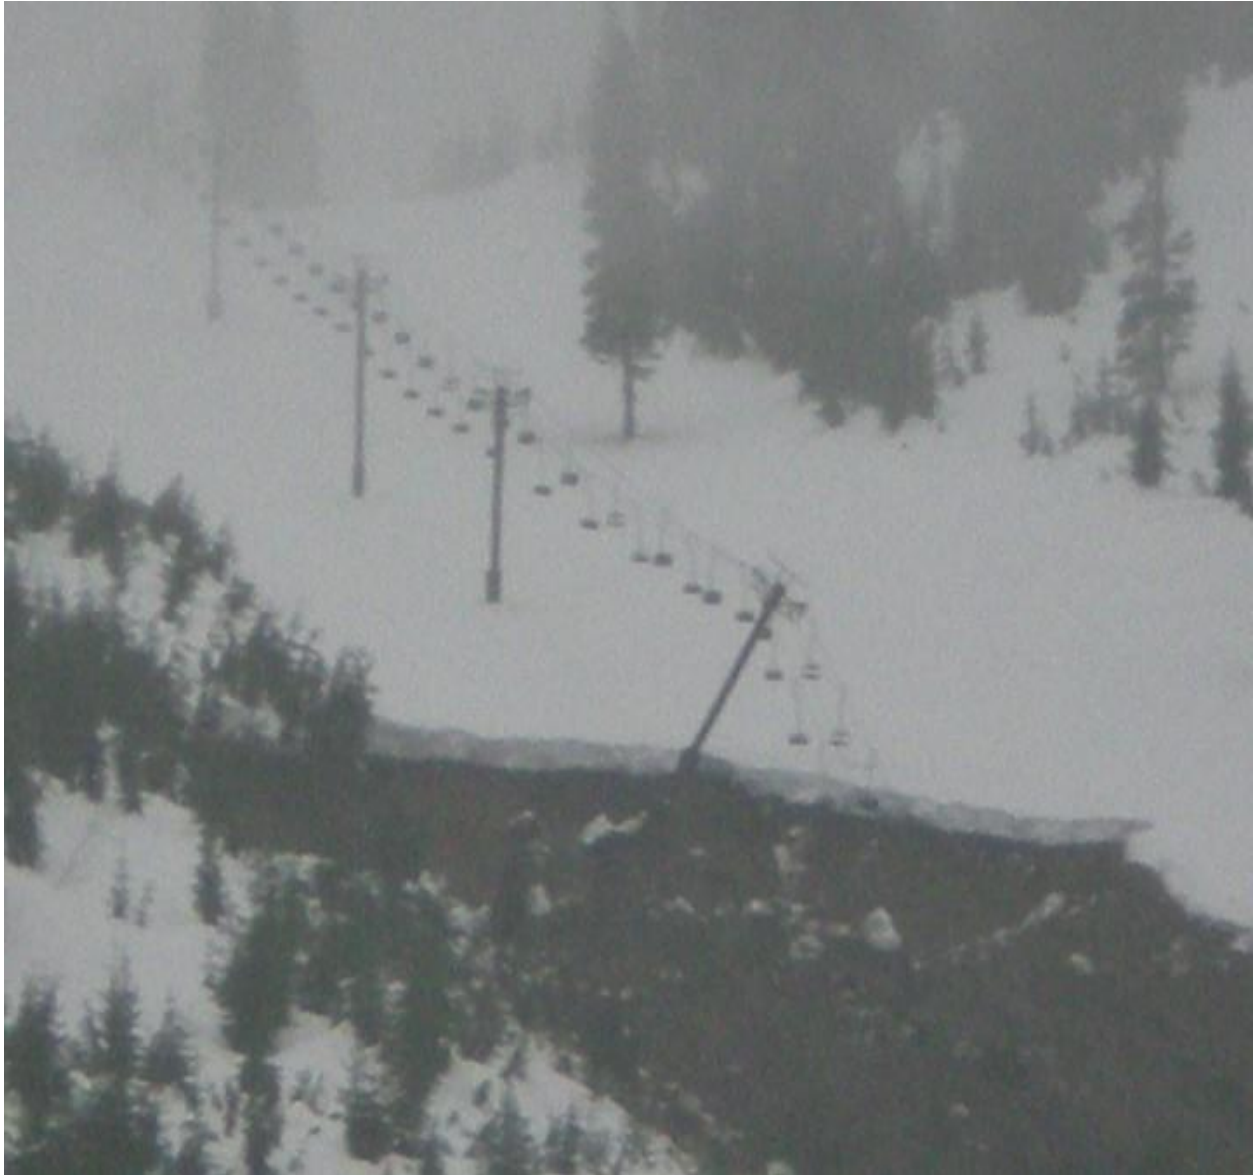
Snowpacks which may get saturated at times with large amounts of rainwater can also fail and cause local slides and can produce catastrophic results.

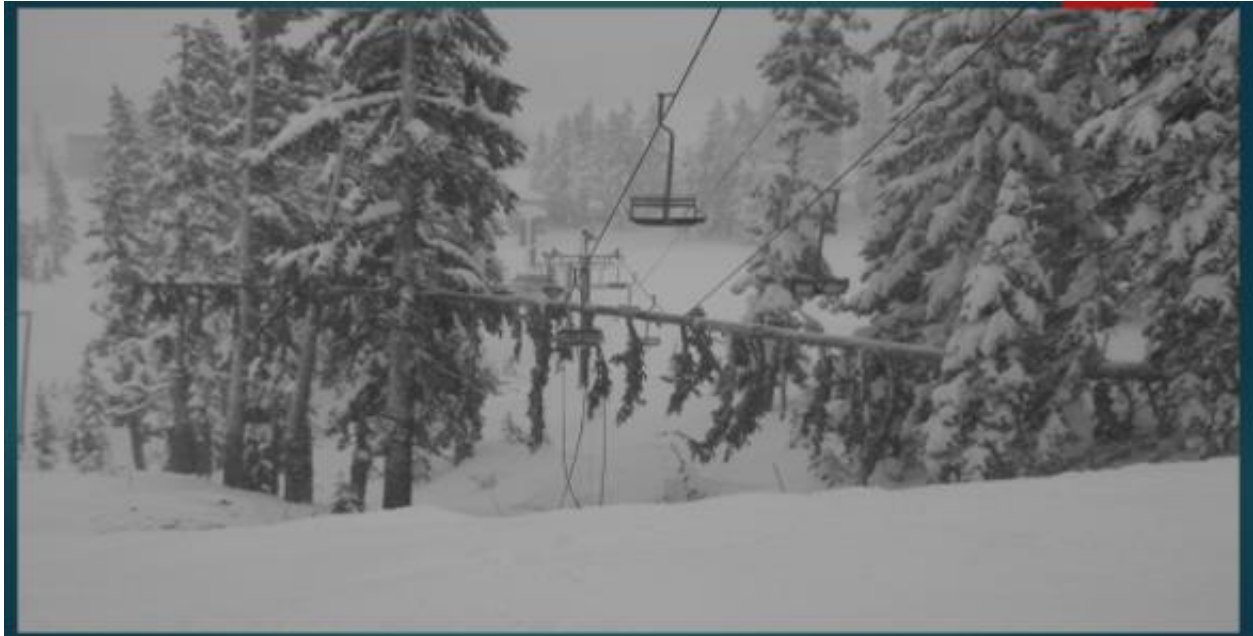
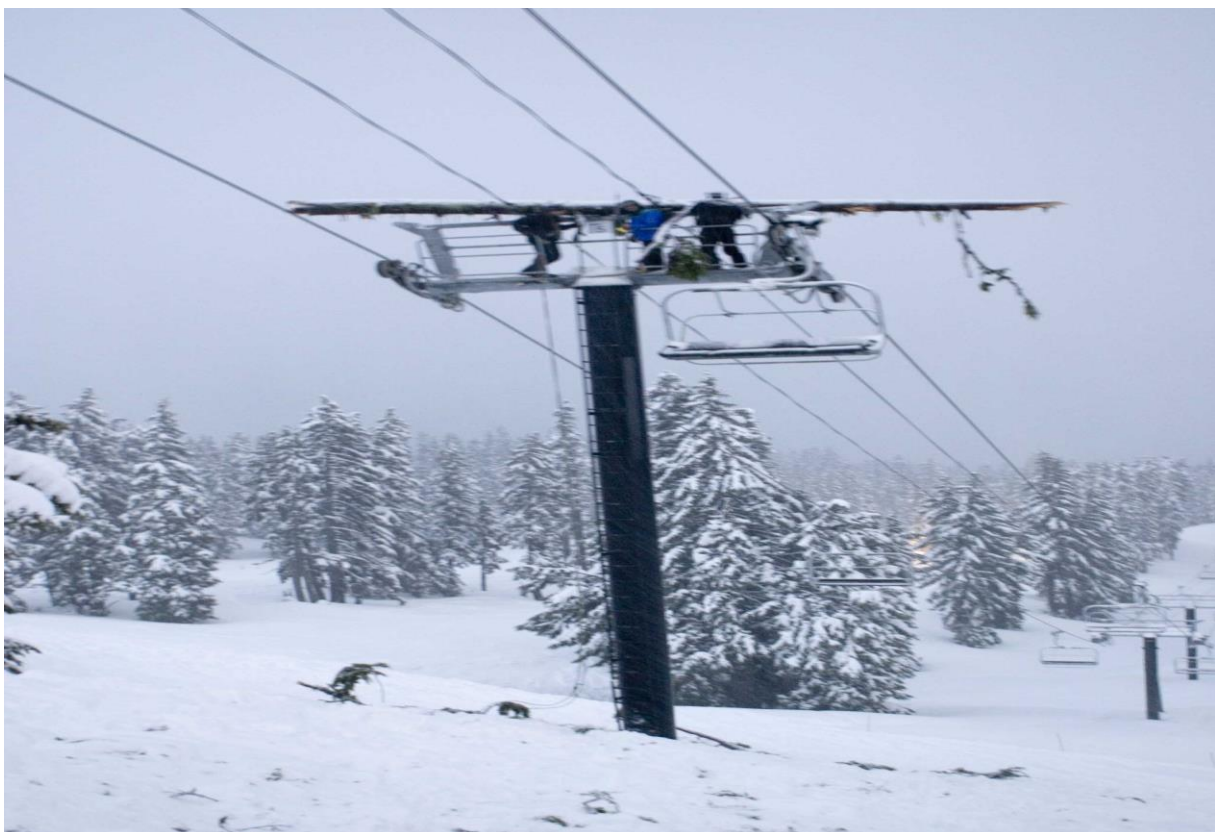
That maritime moisture which saturates the soil can also make some trees more susceptible to uprooting. The Western Hemlock is one such species which is known for uprooting and occasional sudden failure which can come during high wind events.

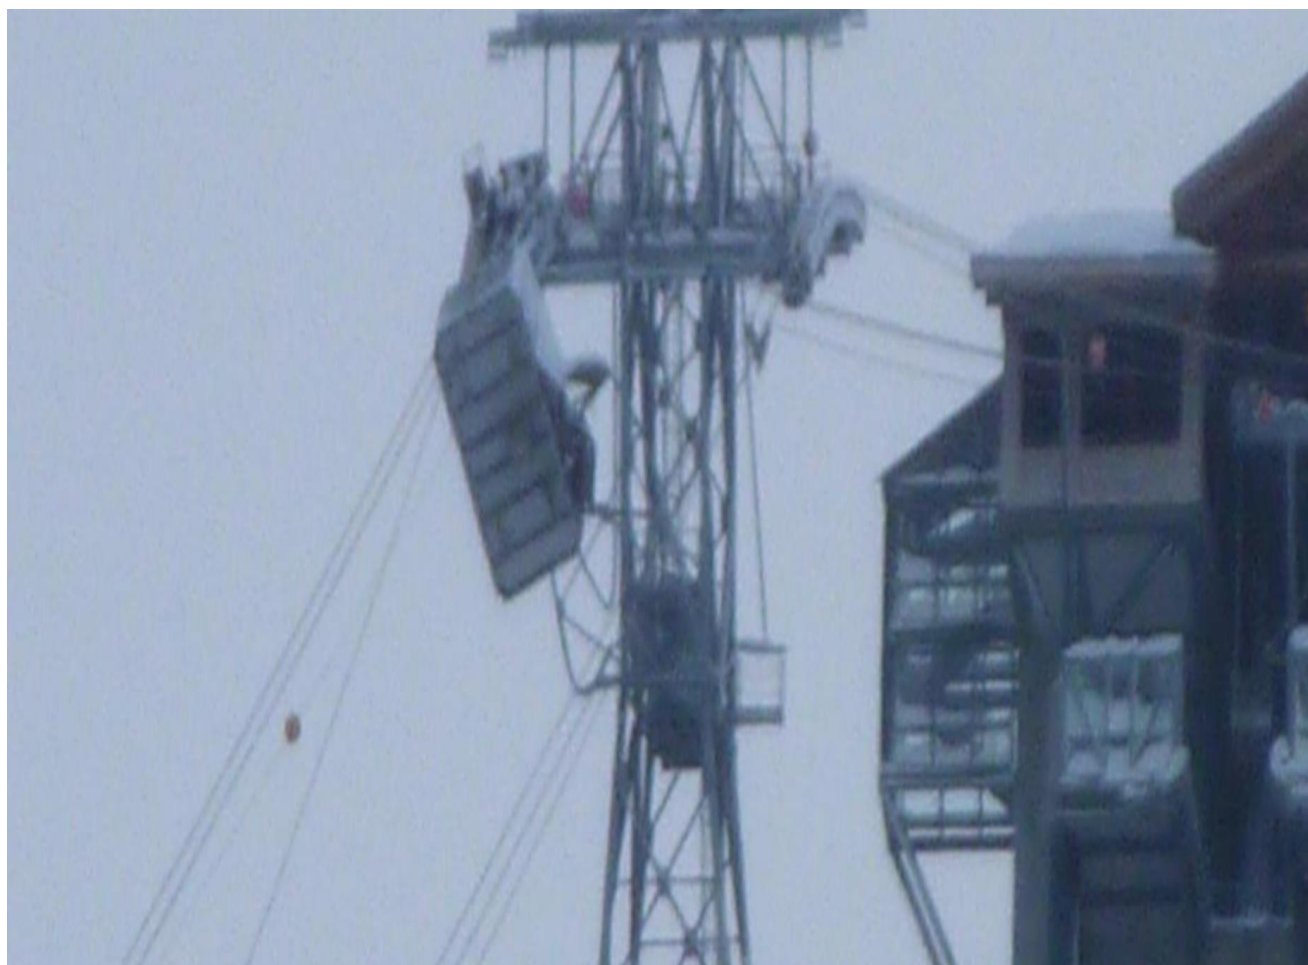
Sudden rough wind gusts can do real damage to ropeways of all sizes. The tram at Alyeska was faced with this scenario during the 2013 holiday season.

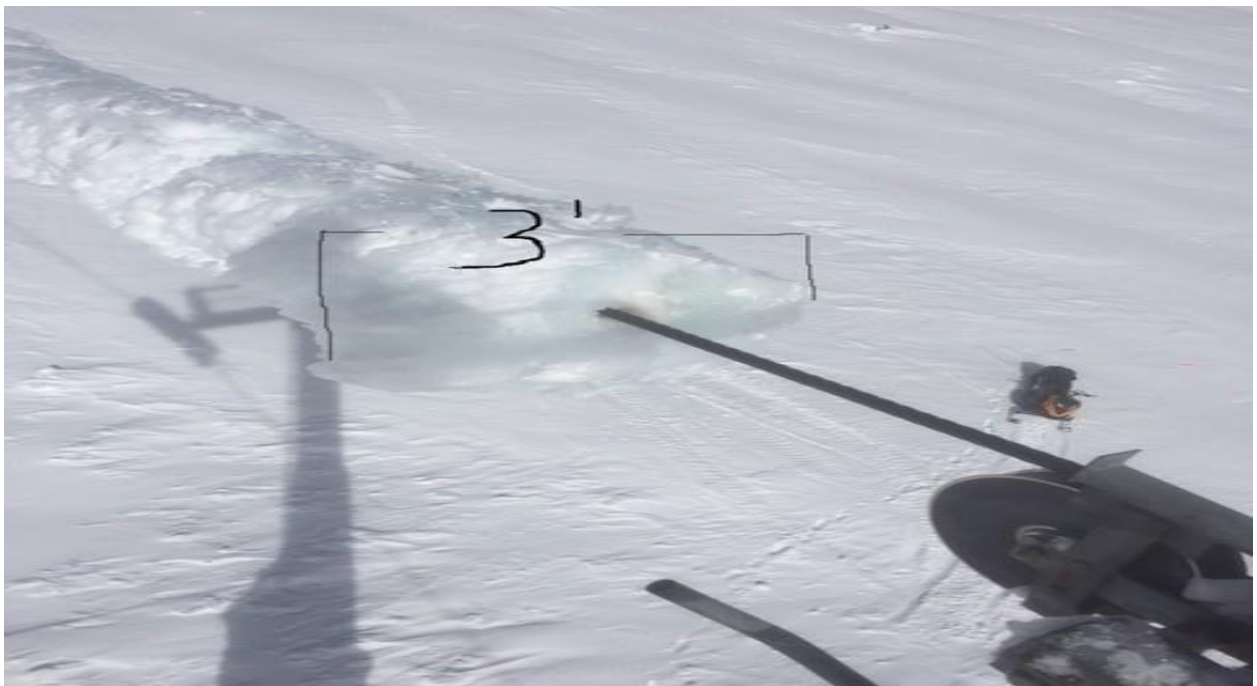
Here is an example of typical ice storm remnants where humidity was high and freezing level was fluctuating and left approximately 36" of mostly hard blue ice with some frothy rime on top which is brought in with the wind towards the end of a storm.

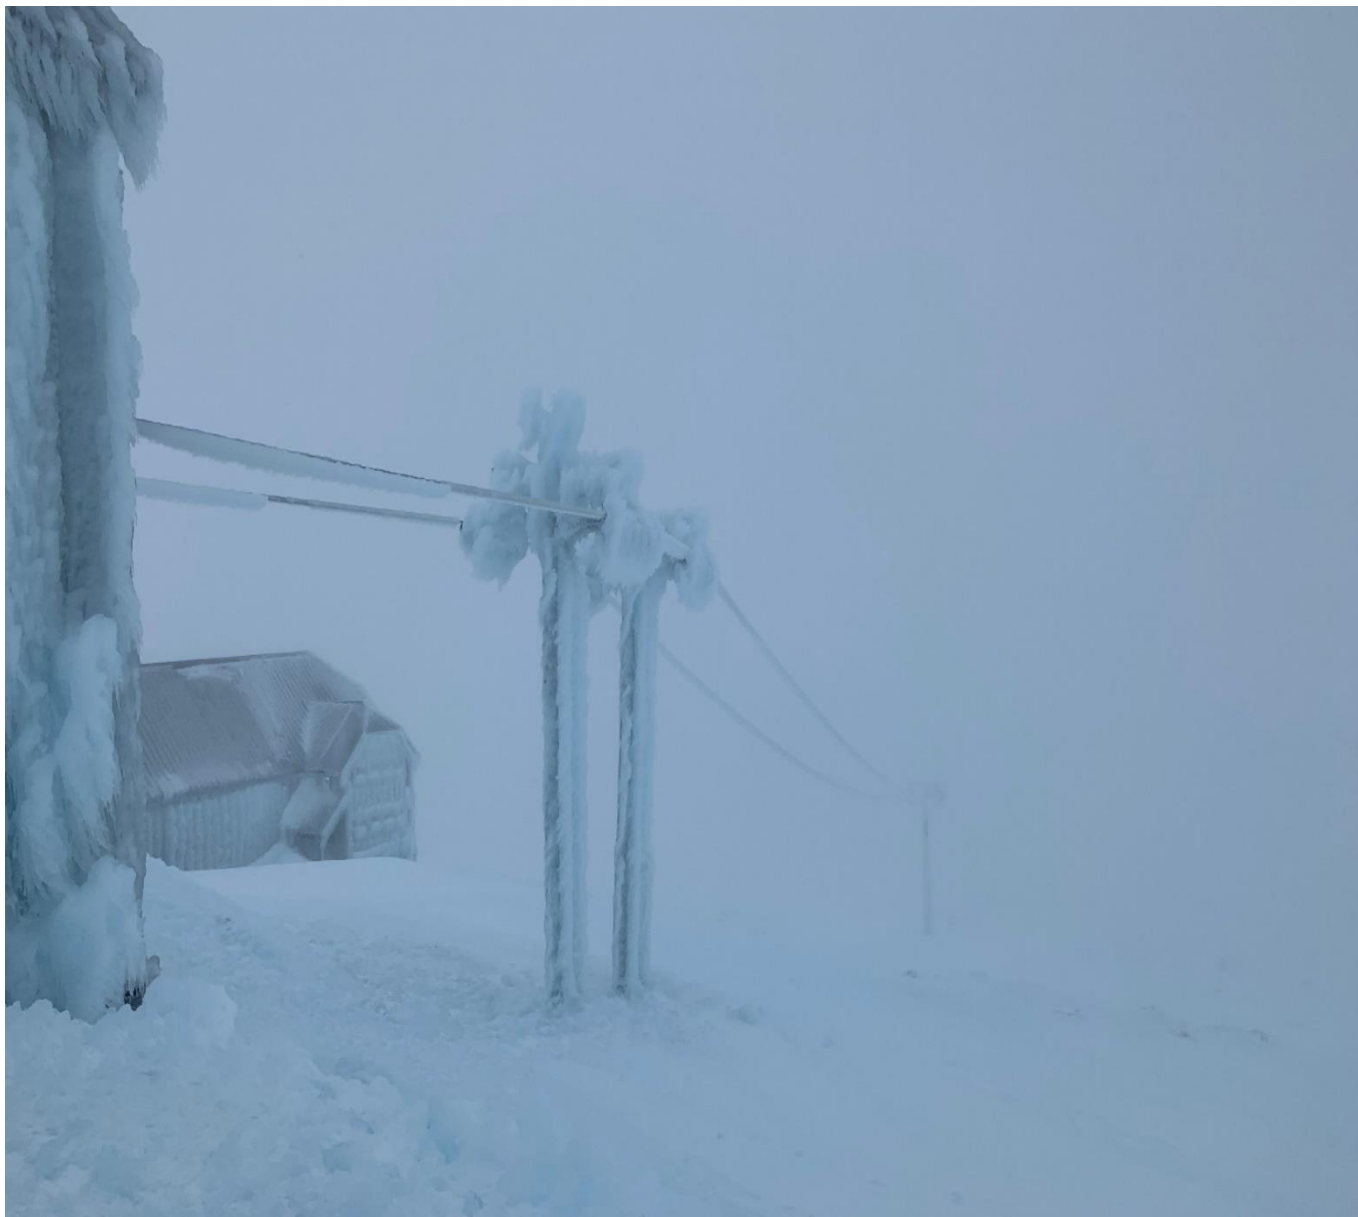
Since Mt. Hood has experienced these icing challenges and conditions with some regularity, it has allowed some successful methods to be developed over the years. It has also put some lift designs to the absolute limit.

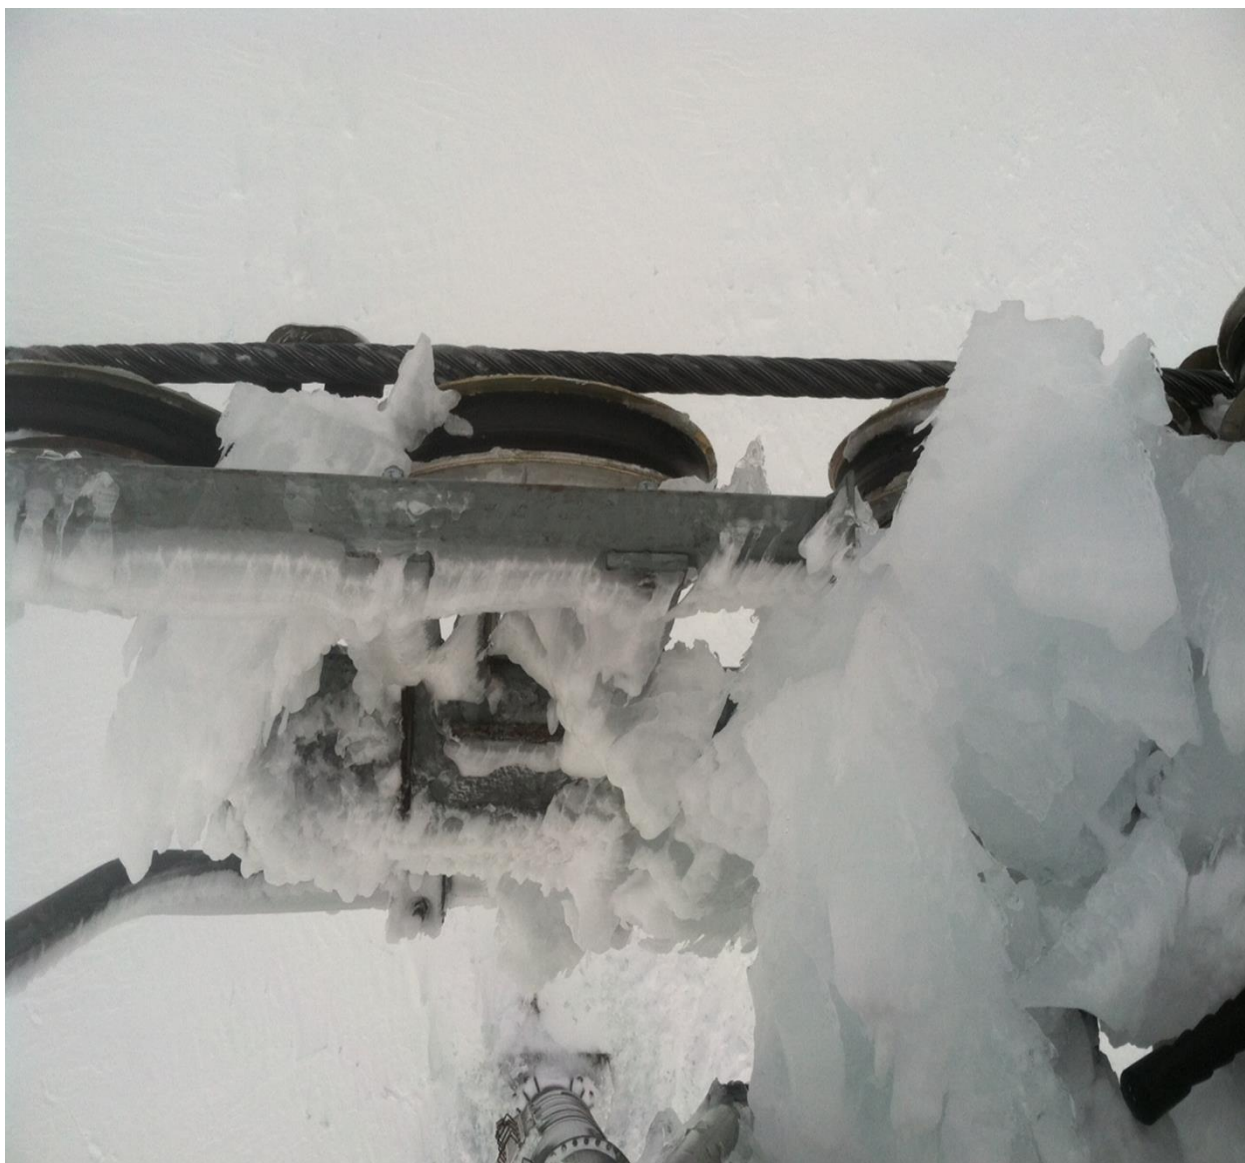
Often, high winds will derail the empty rope when carriers are removed, breaking a brittle bar thus stopping the lift, which then causes large diameter ice to build on the cable. Other times, tower machinery and sheaves will freeze and stop turning while the cable continues to move which then destroys sheaves, axles and shafts by the moving cable which acts as a giant band saw. This action can saw through axles and shafts throughout the course of a couple of days before a cut brittle bar wire finally will stop the lift.

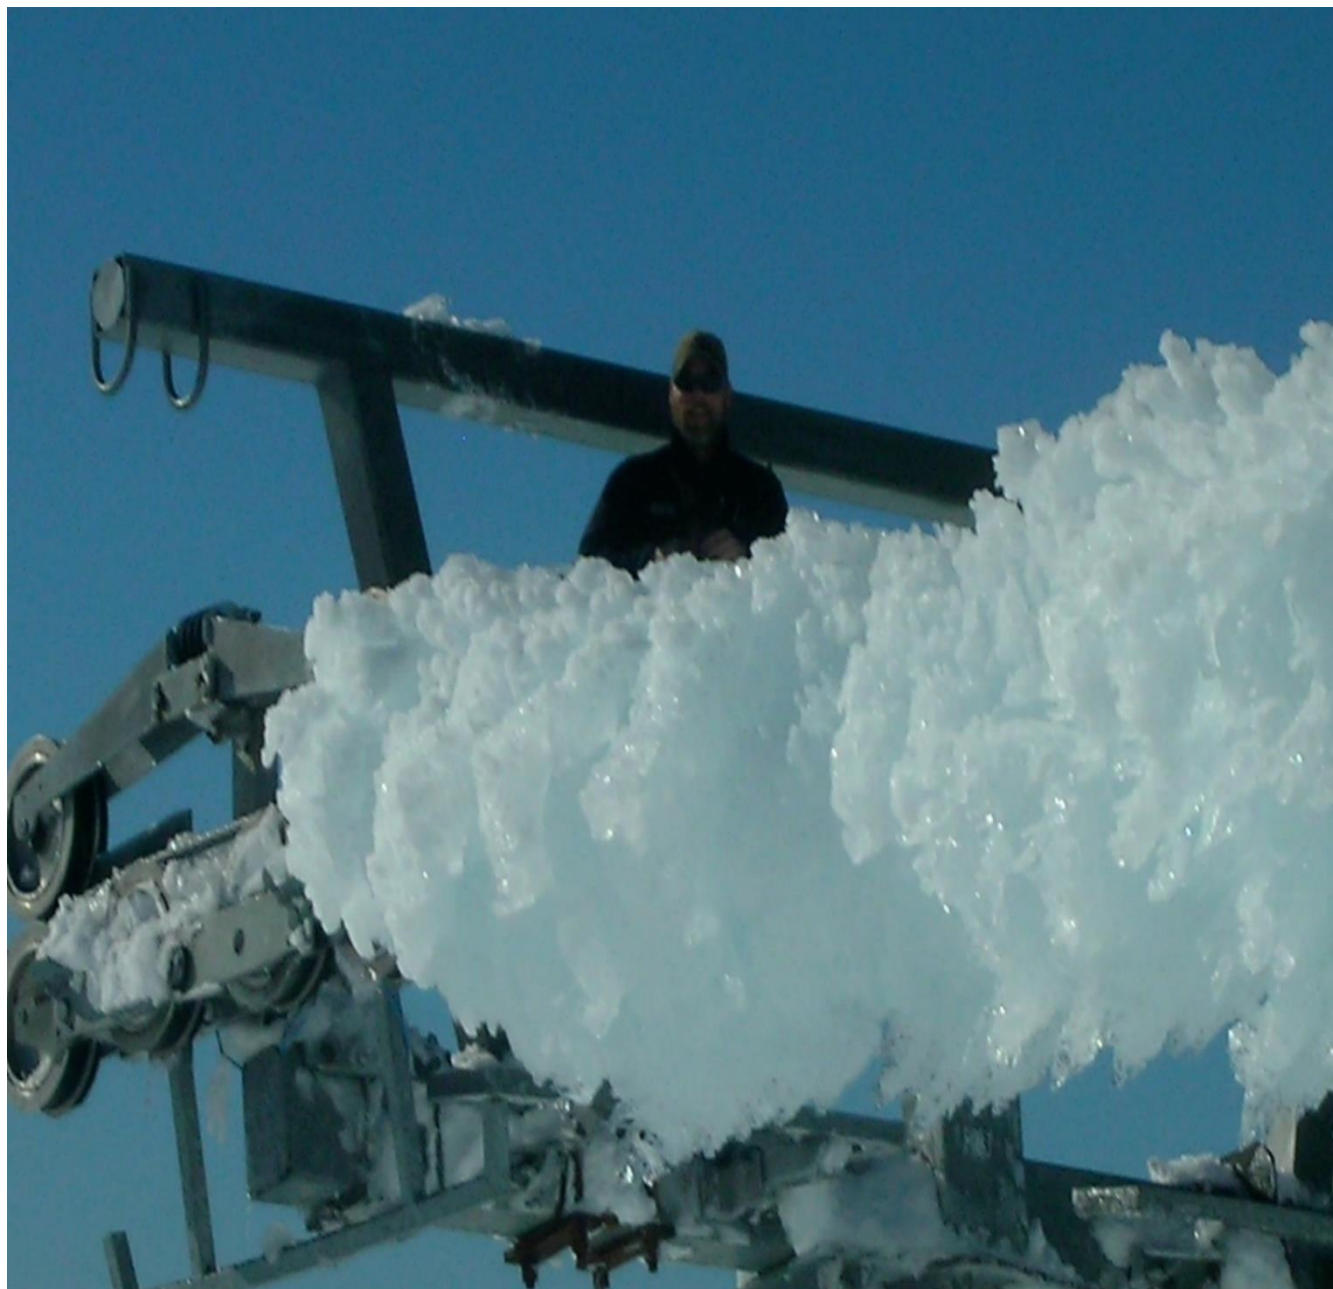
Once the lift has stopped in night drive mode then the effort required for removal of the ice gets much more involved.

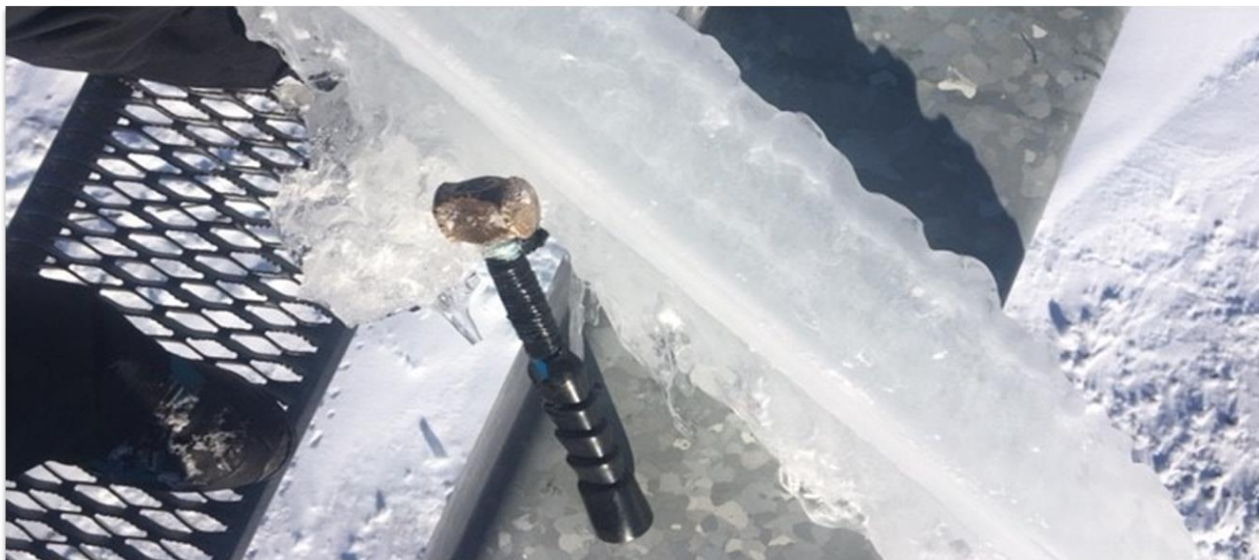
Soft rime ice may often be brushed away with a broom, but it can also be a multi-day battle to safely remove the ice. Most ice storms at a ski area require some type of manual de-icing, generally done with some type of large, soft-faced hammer. To remove the ice from the cable, many methods are used. Small amounts of ice can be knocked off the cable by running the lift and allowing the ice to go through the sheave assembly. Care must be taken to protect brittle bars and to avoid derailments. Large ice may take other methods and since wind shear forces increase exponentially with each inch of ice, entire ski lift towers can buckle under the weight if left neglected.

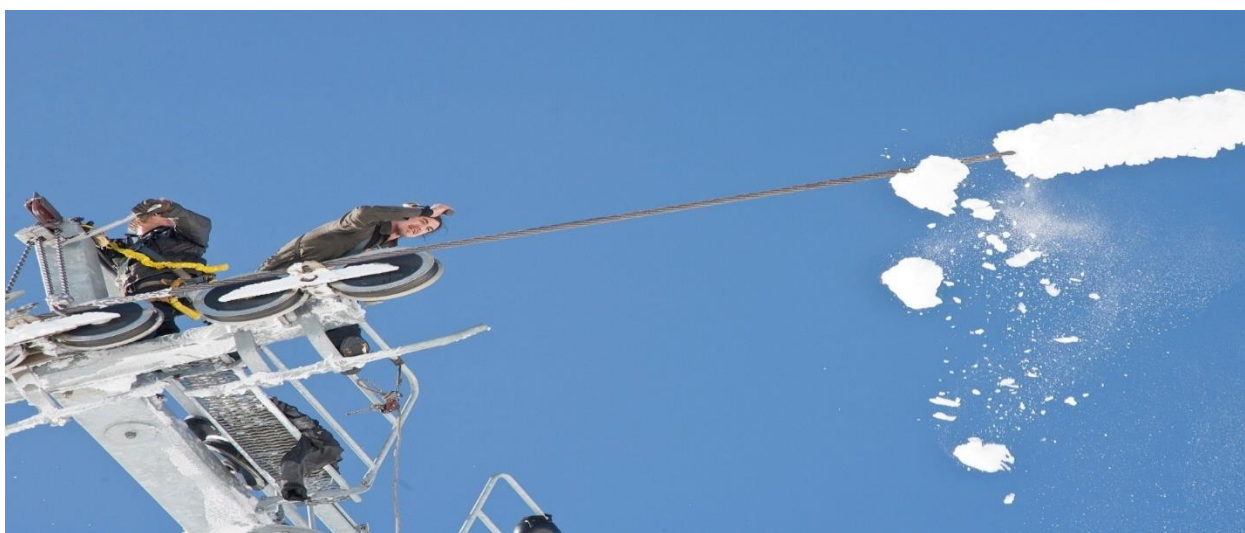
With the added weight of the ice on the cable it is often too heavy for most winches or hoists to lift the rope back onto the sheaves so the ice must be stripped clean first.

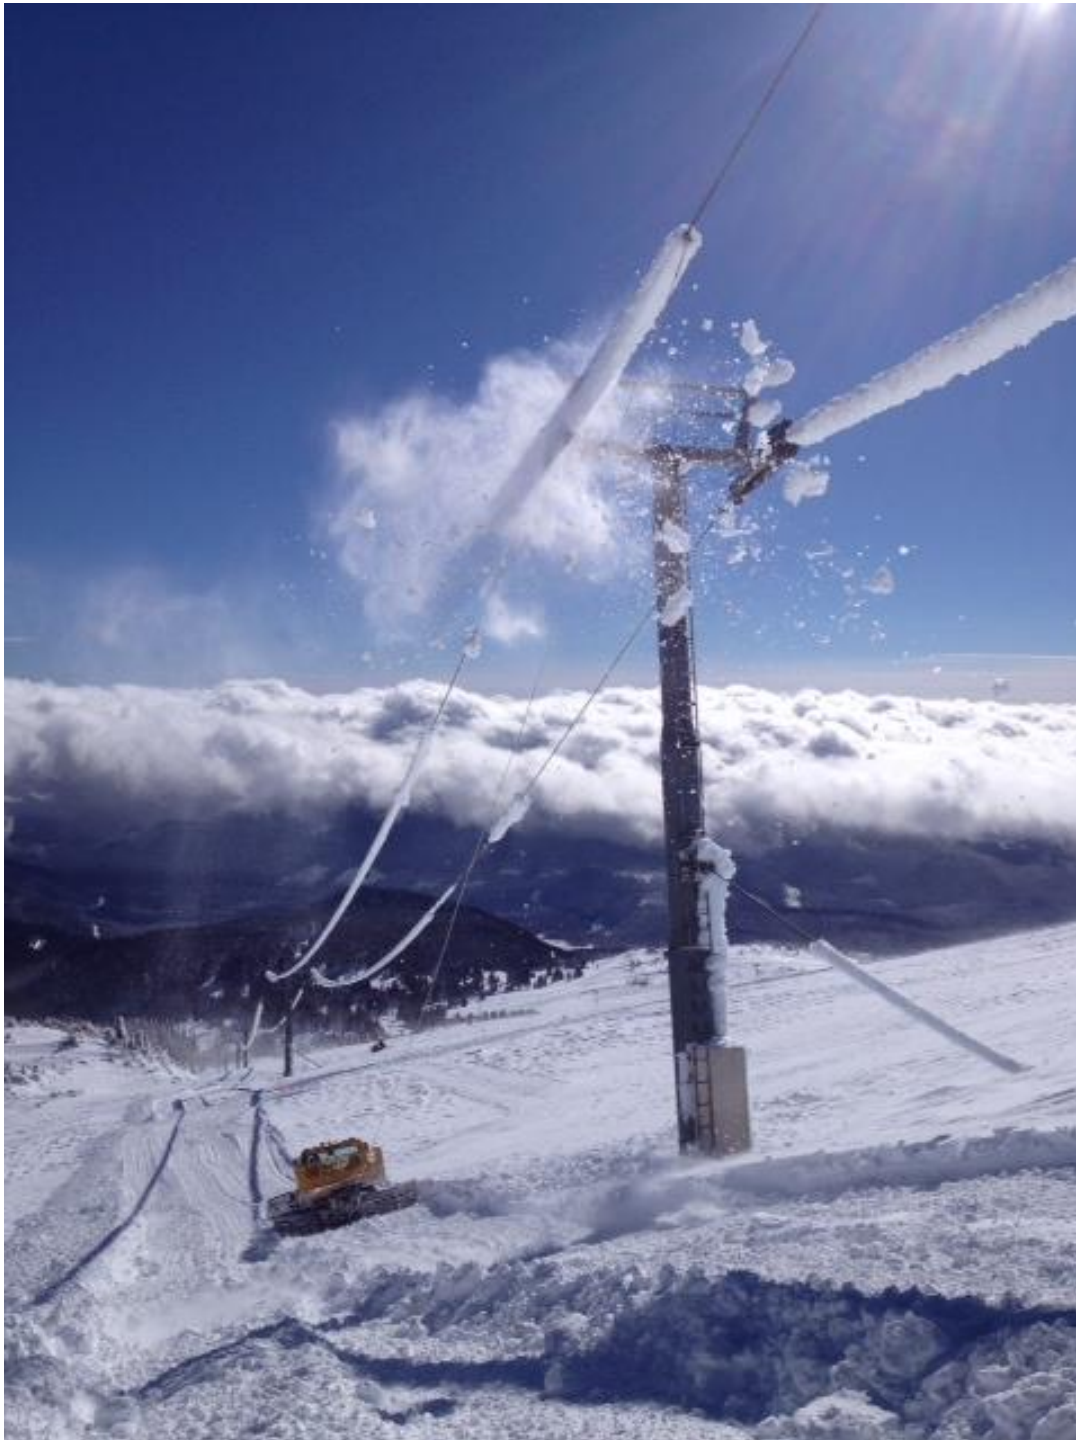
This process is time consuming but one of the most successful processes has been to install a shackle on the haul rope and pull it along the length of rope by connecting it to a snow cat via a rope sling. As the cable clears itself of ice, it can be quite dramatic. Depending on the force of the pull, many towers need to be tied down to prevent more derailments.

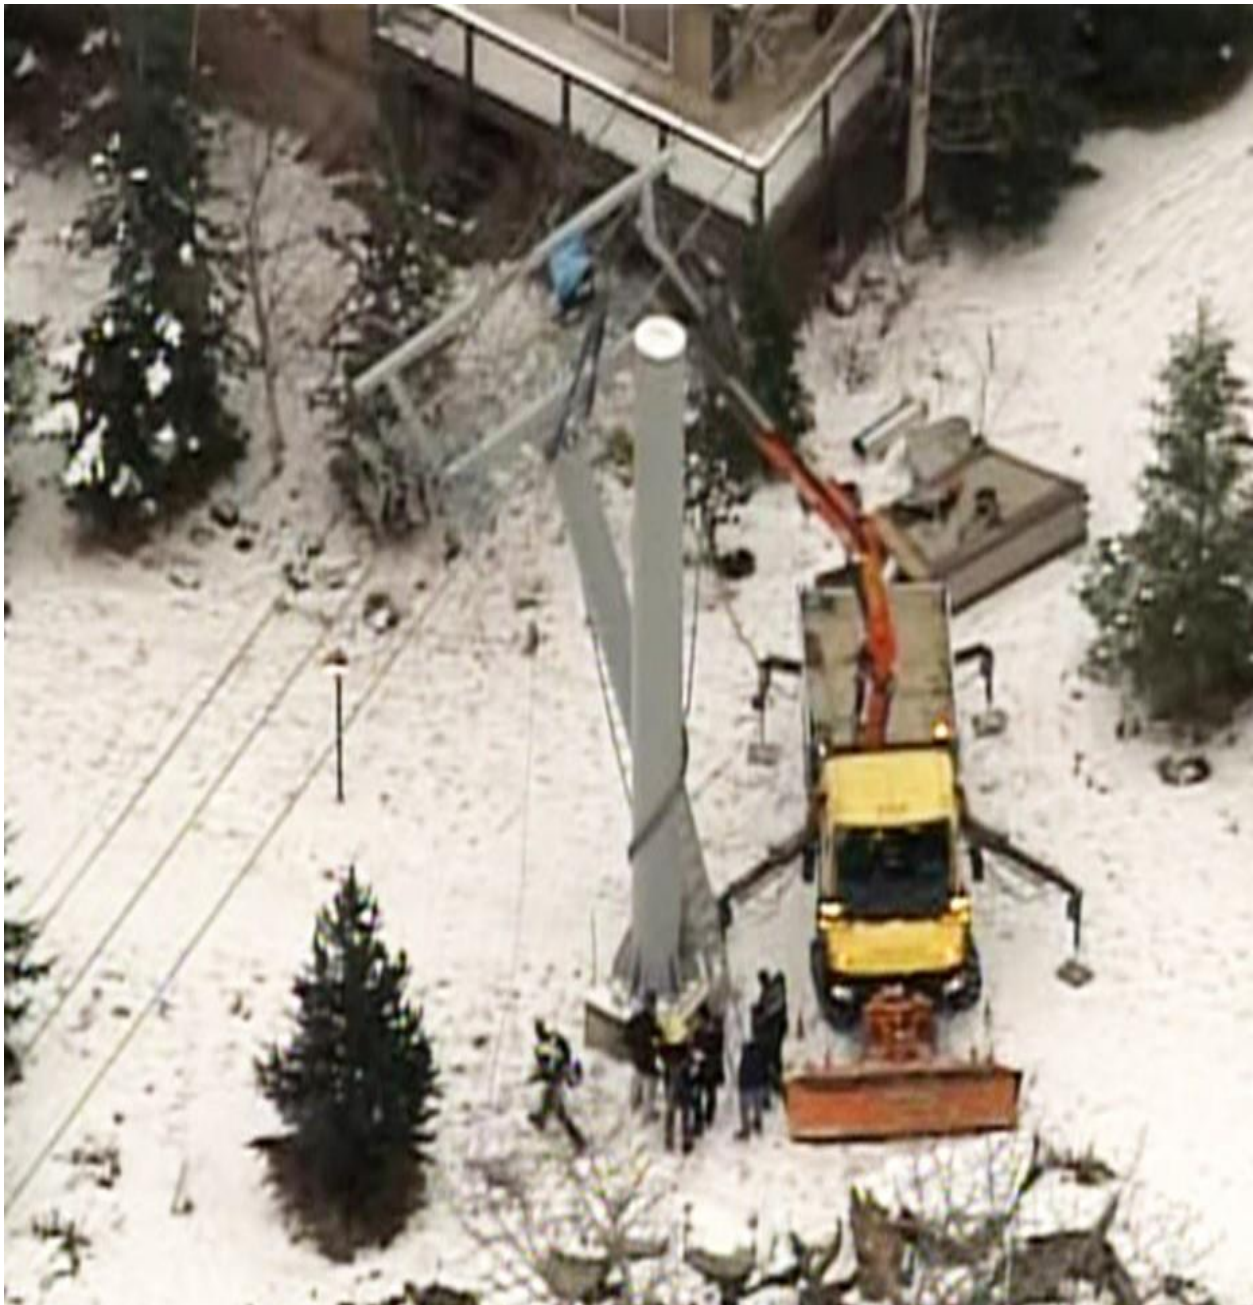
The effect of ice goes beyond what is often visible as well. Ice jacking inside towers has been a problem in these moist climates. The Whistler gondola once was evacuated when an upper section of tower was lifted off its lower section. Water turned to ice inside the tower and its upward expansion snapped the connection fasteners which broke the tower in two .
