# Weather Challenges in Ropeway Operations & Maintenance

Tom Scully-USA  
Risk Control Consultant-Safehold Special Risk  
Tom.scully@safehold.com

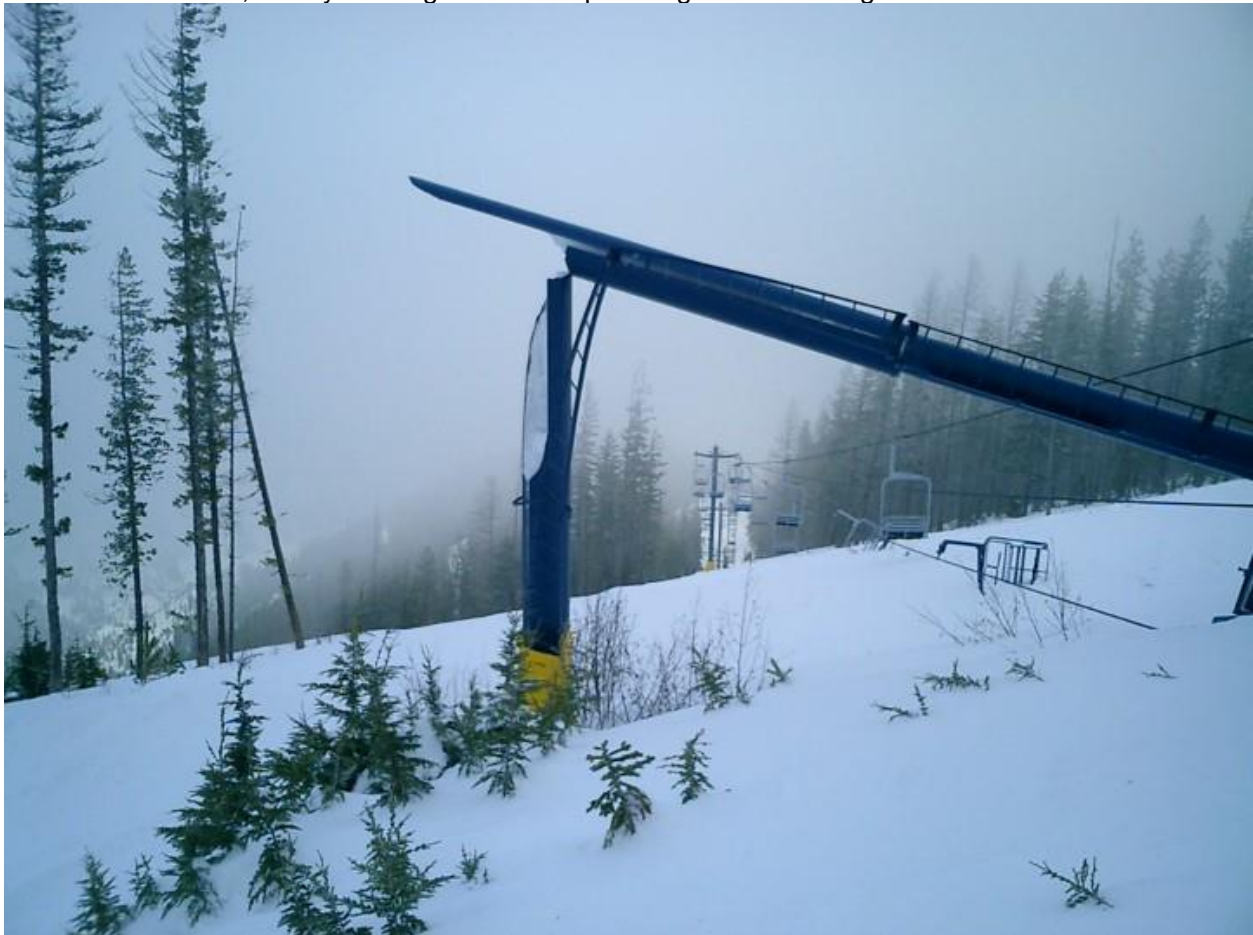
Additionally, ice jacking left unnoticed caused nearly 100 feet of cracks in a tower causing catastrophic failure of the tower, luckily overnight when no passengers were riding the lift.

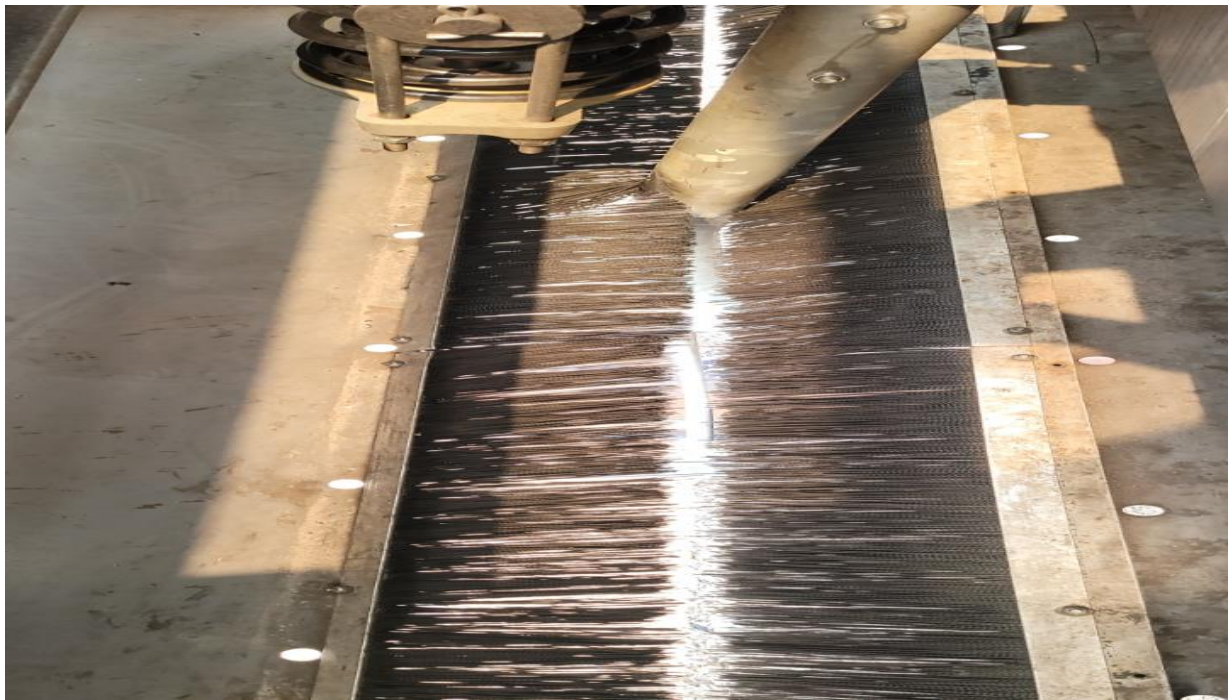
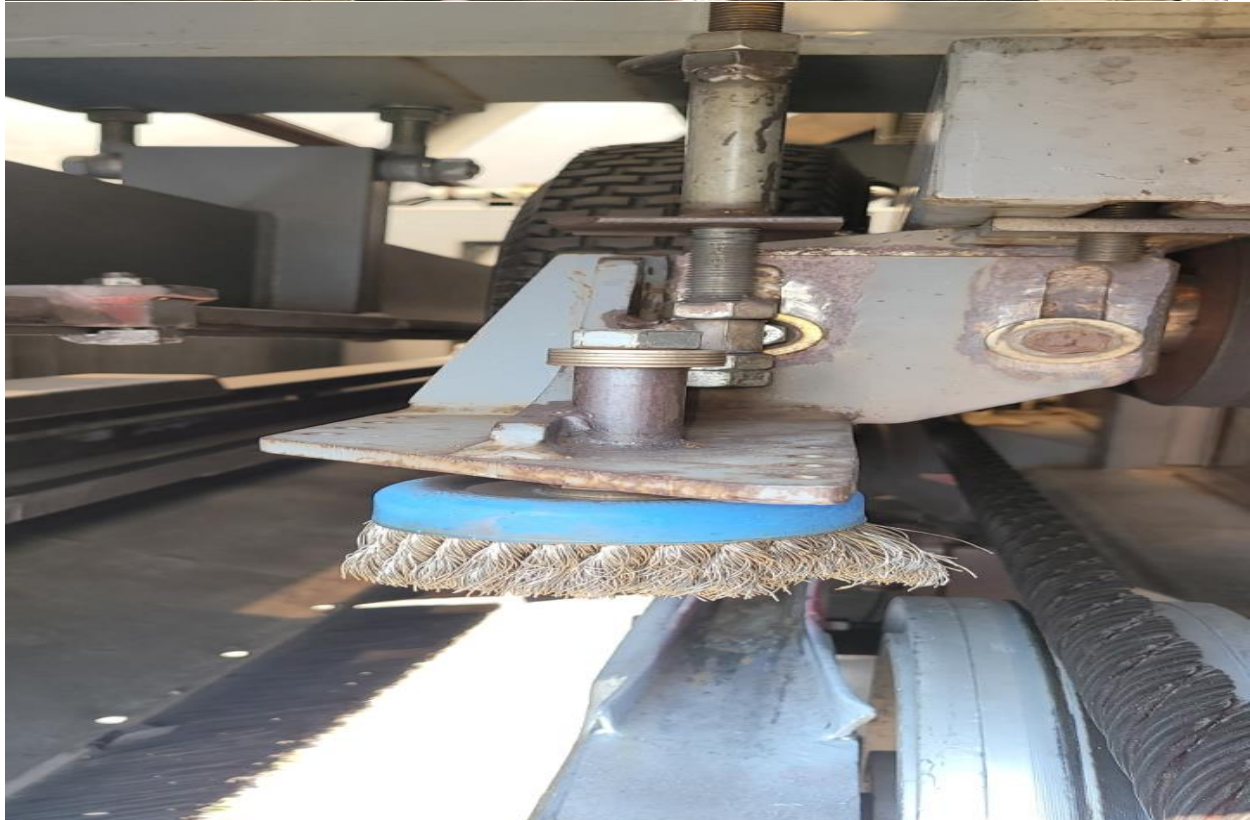
Now as other parts of the country are seeing changes in their weather patterns, they may begin to see ice and rime affecting their lifts and operating schedules. This change in weather may necessitate more advanced lift technology and lift icing options in regions other than just then the Pacific Northwest. Some options which have been made available to all buyers are underbelly brushes and grip path brushes. Below are early versions of these tools.

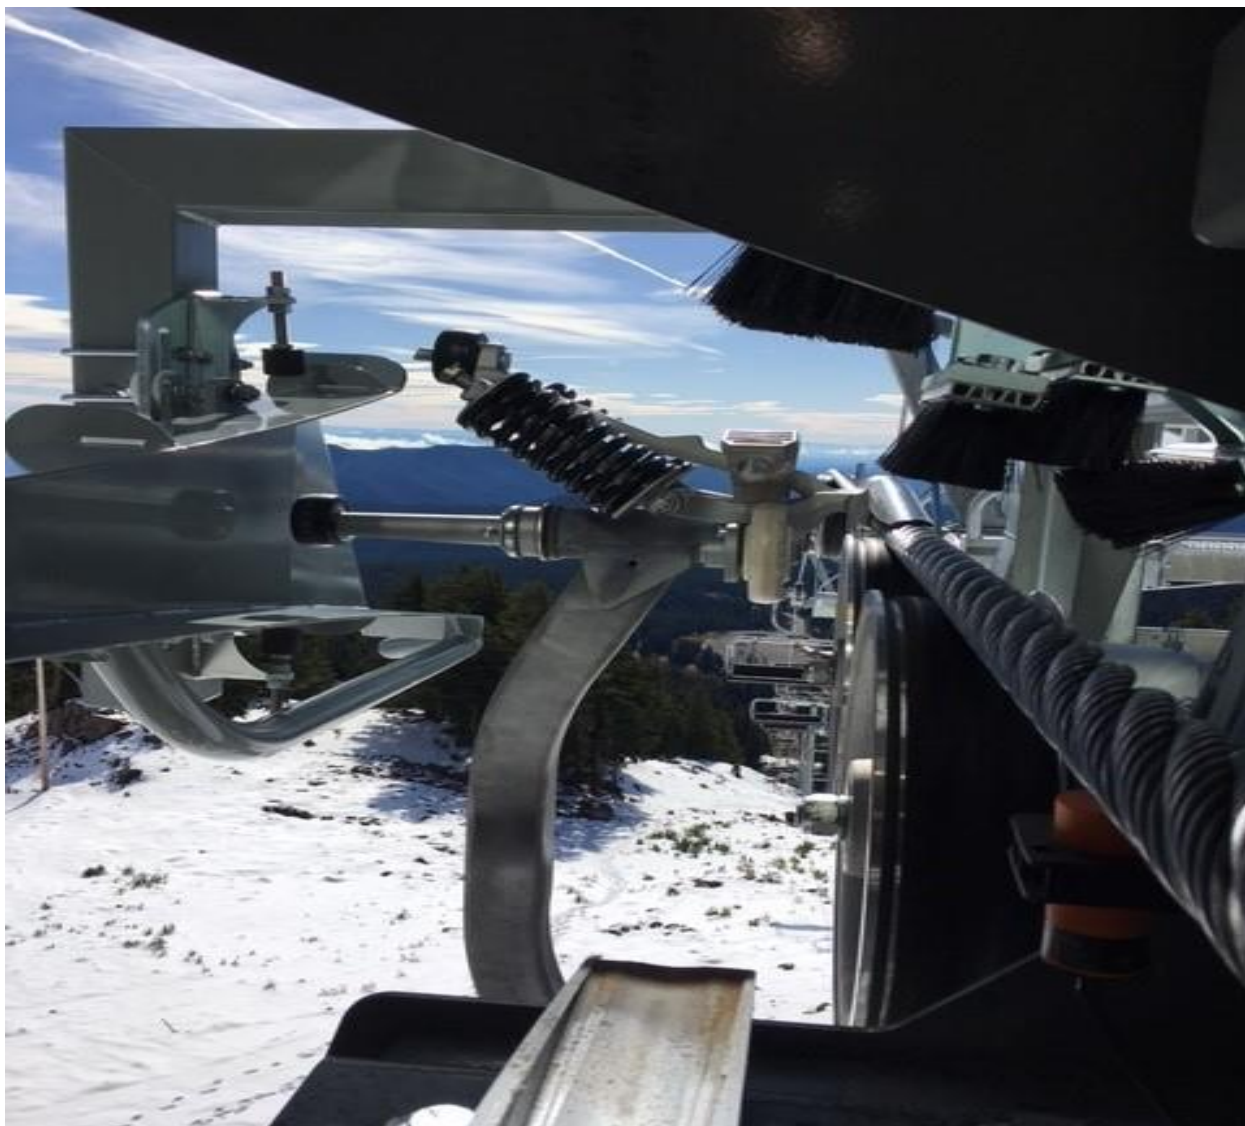
Now we fast forward a couple of decades and lifts come with options or standard equipment which have been refined by the manufacturer. Adjustable terminal entrance grip brush shown below and the following page from inside a newer terminal.

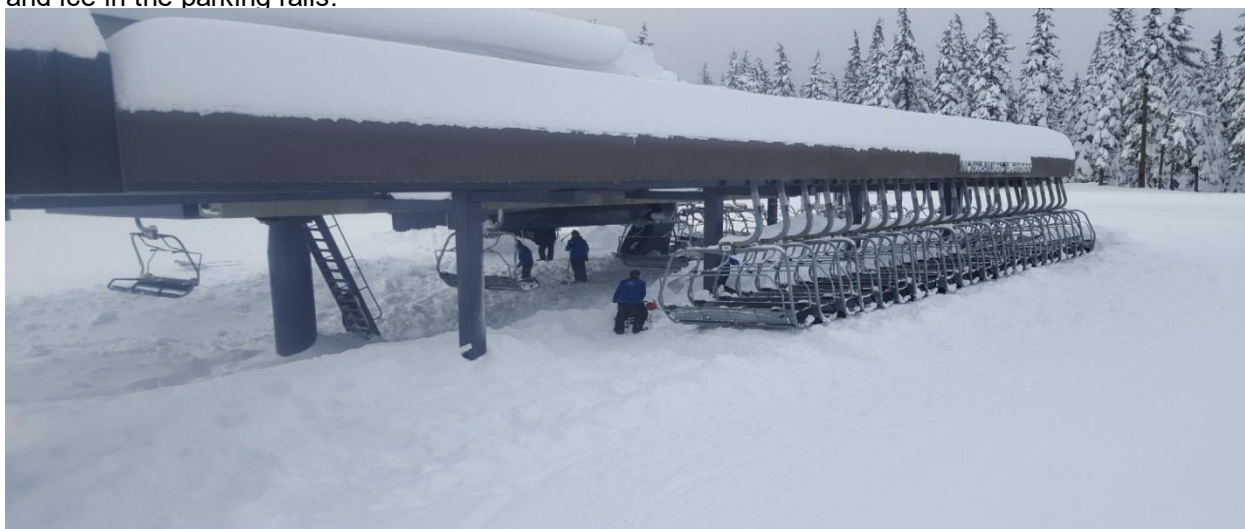
Despite improvements to grips and terminals, advancements in night drive operation and parking of carriers was still needed in many locations. Cost is a major consideration for many resorts when purchasing a new lift and often a parking garage makes the lift cost impractical for many resorts. Covered parking rails was another way to remove chairs from the cable without having to build large enclosed parking storage but this can increase the manual work required to keep the chairs and grips free of snow and ice in the parking rails.

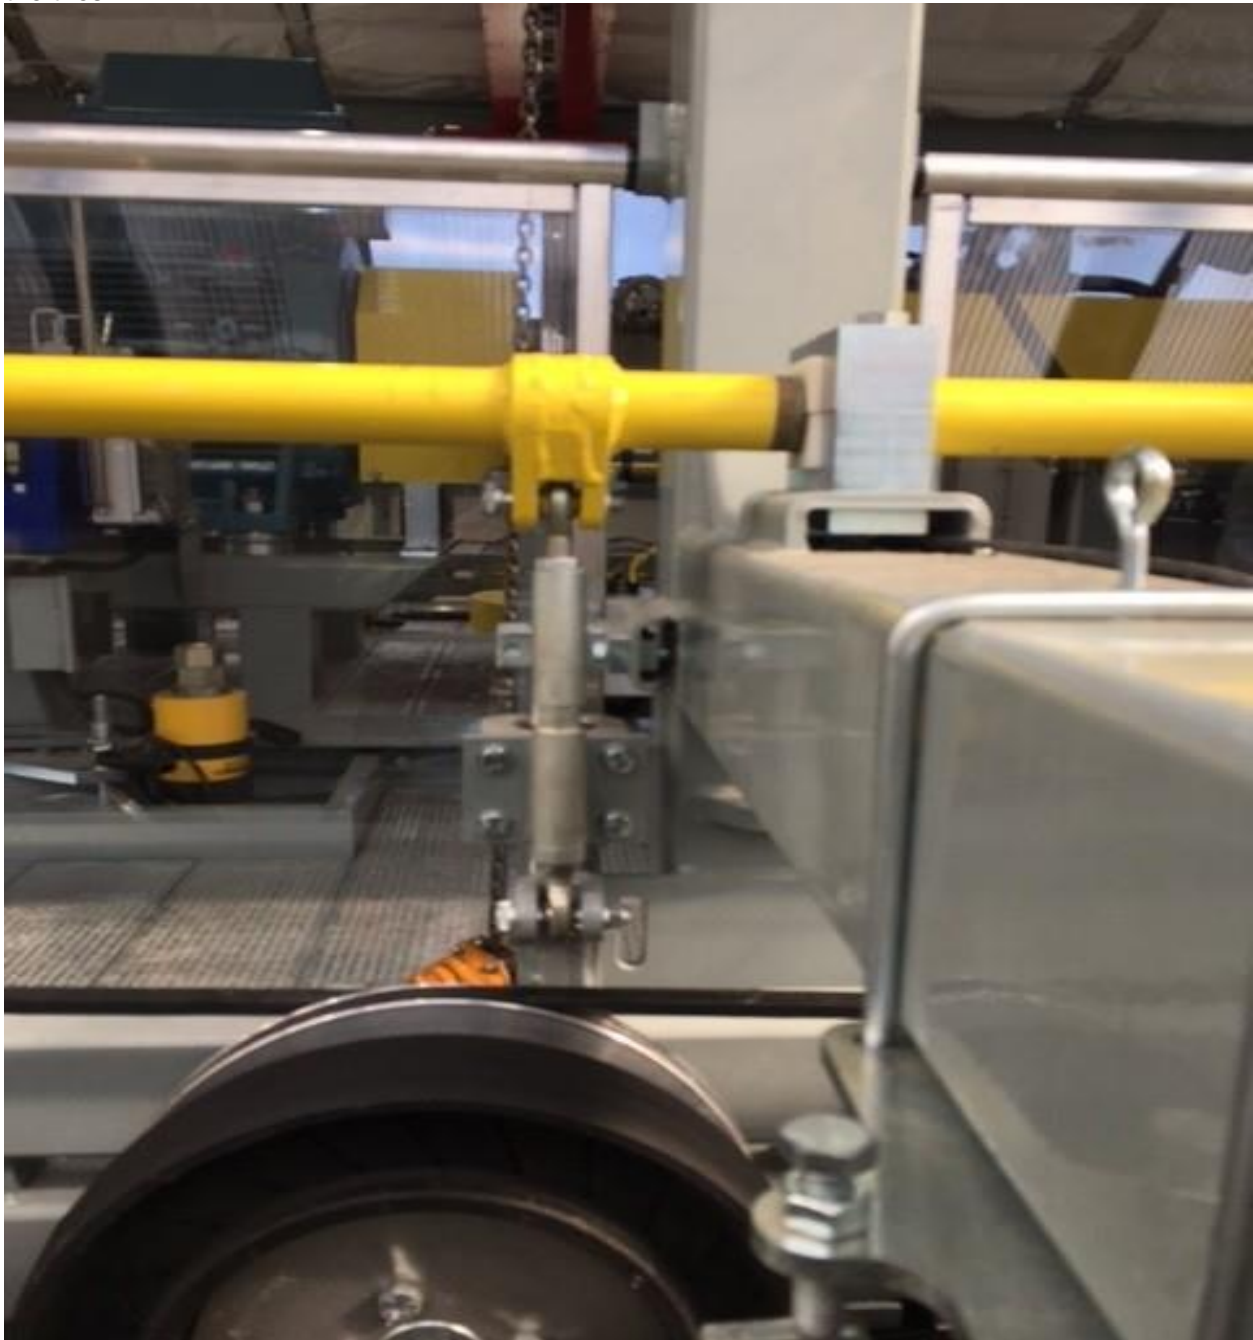
Next was improvements to the terminal tire beam by Doppelmayr and Poma which could allow the detachable tire rails to be raised thus allowing chairs to be parked inside the terminal itself while still giving the option of running the lift cable on night drive mode even with the chairs in the terminal. This is accomplished by raising the entire tire beam and pushing chairs along the rail without any contact with the tires.

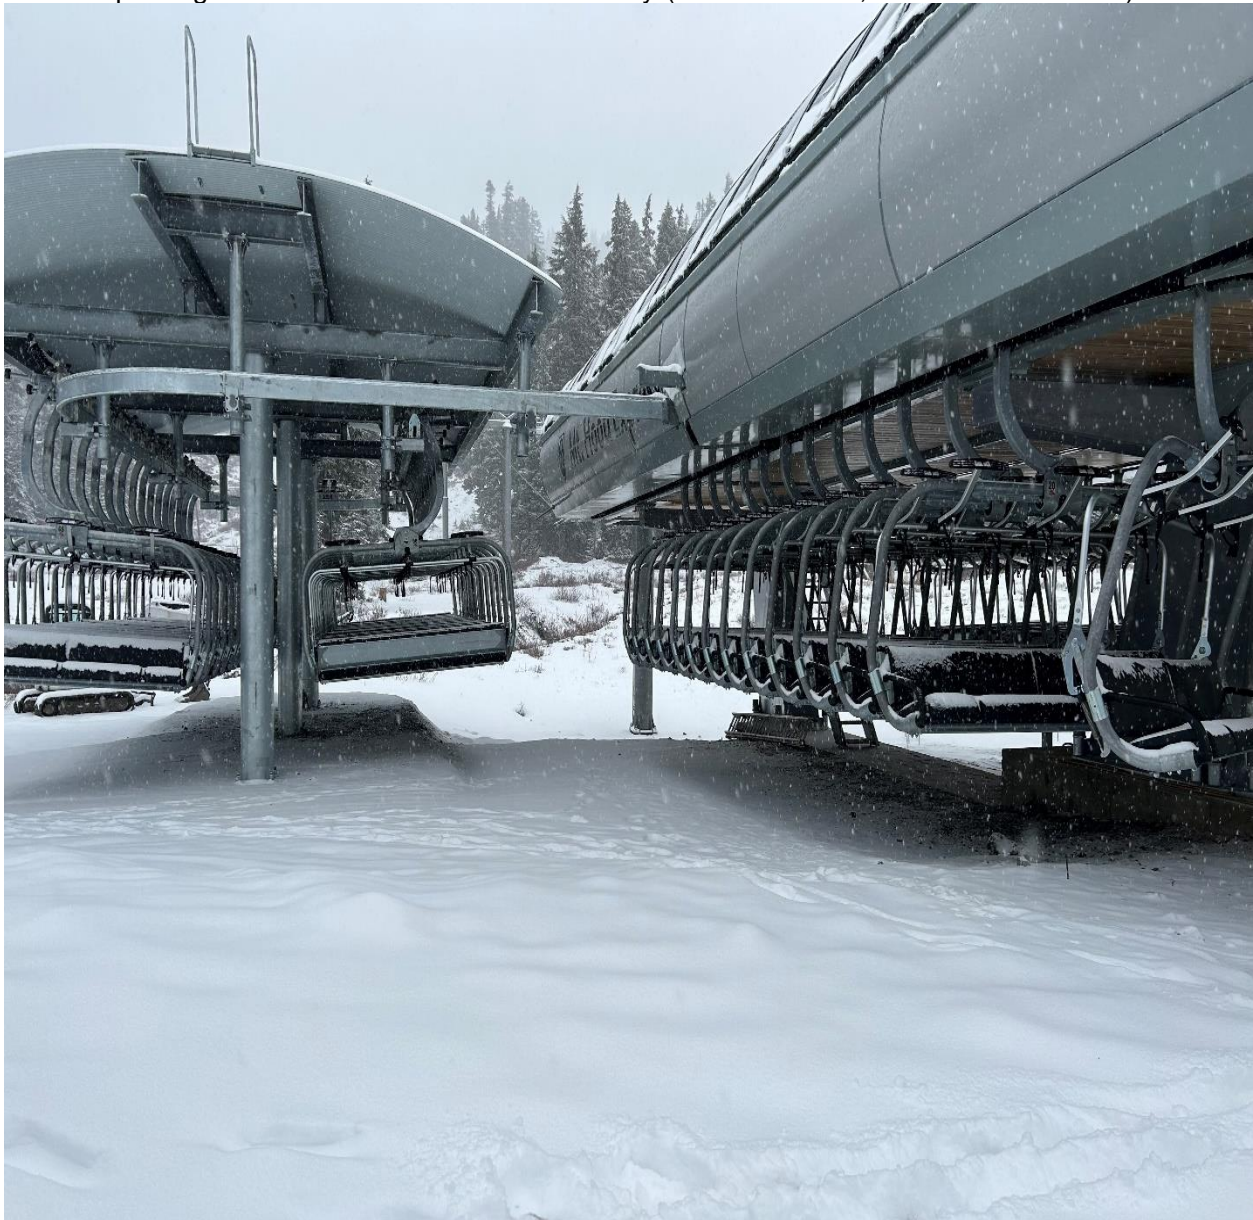
Some lifts such as the one shown here park 1/3 of the chairs in each terminal and the last 1/3 under a smallish parking rail which lowers cost considerably (Photo: Woods, Mt. Hood Meadows).

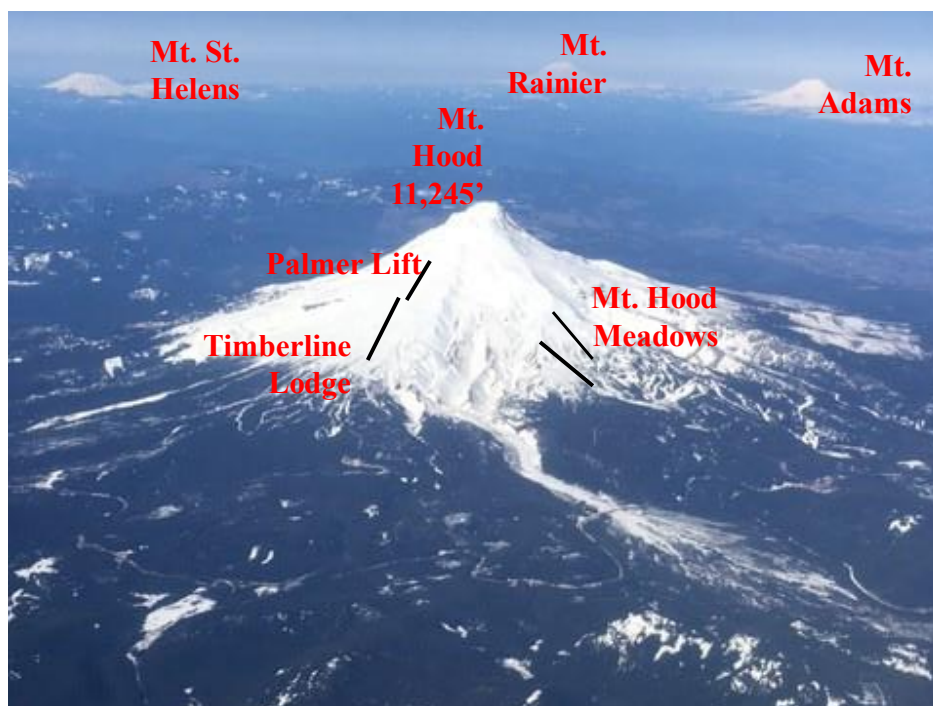
In 1996, the current Palmer was constructed by Doppelmayr. A high-speed detachable quad with a mid-station load (used in summer months). All equipment was new with the exception of the line towers, though a few new towers were added. Knowing of the historic icing events Doppelmayr designed the lift with a night drive mode to run during storms with carriers removed to prevent ice build up. Since that time, the lift went through hellish winters and mainly operated during the summer months for ski race camps.

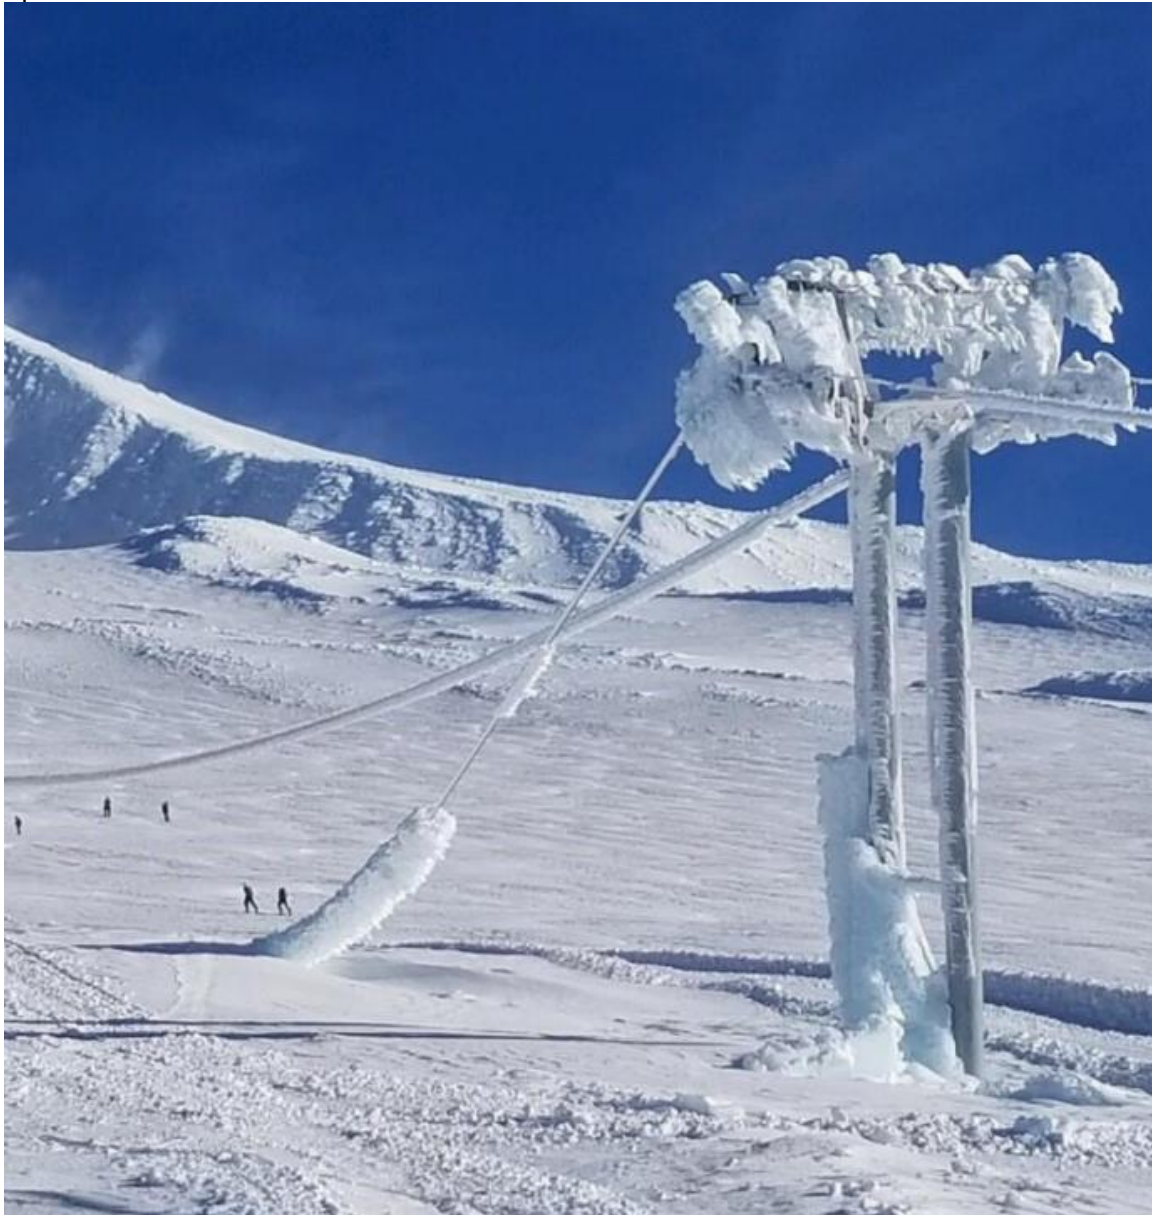
Most recently in 2019-2020, the haul rope was retired after it exited the tower machinery and pushed one assembly more than 50 feet away from the tower. Two other towers had the cable land on top of the lifting frames during the event, causing one to completely fail and fall from tower while another was bent beyond repair.

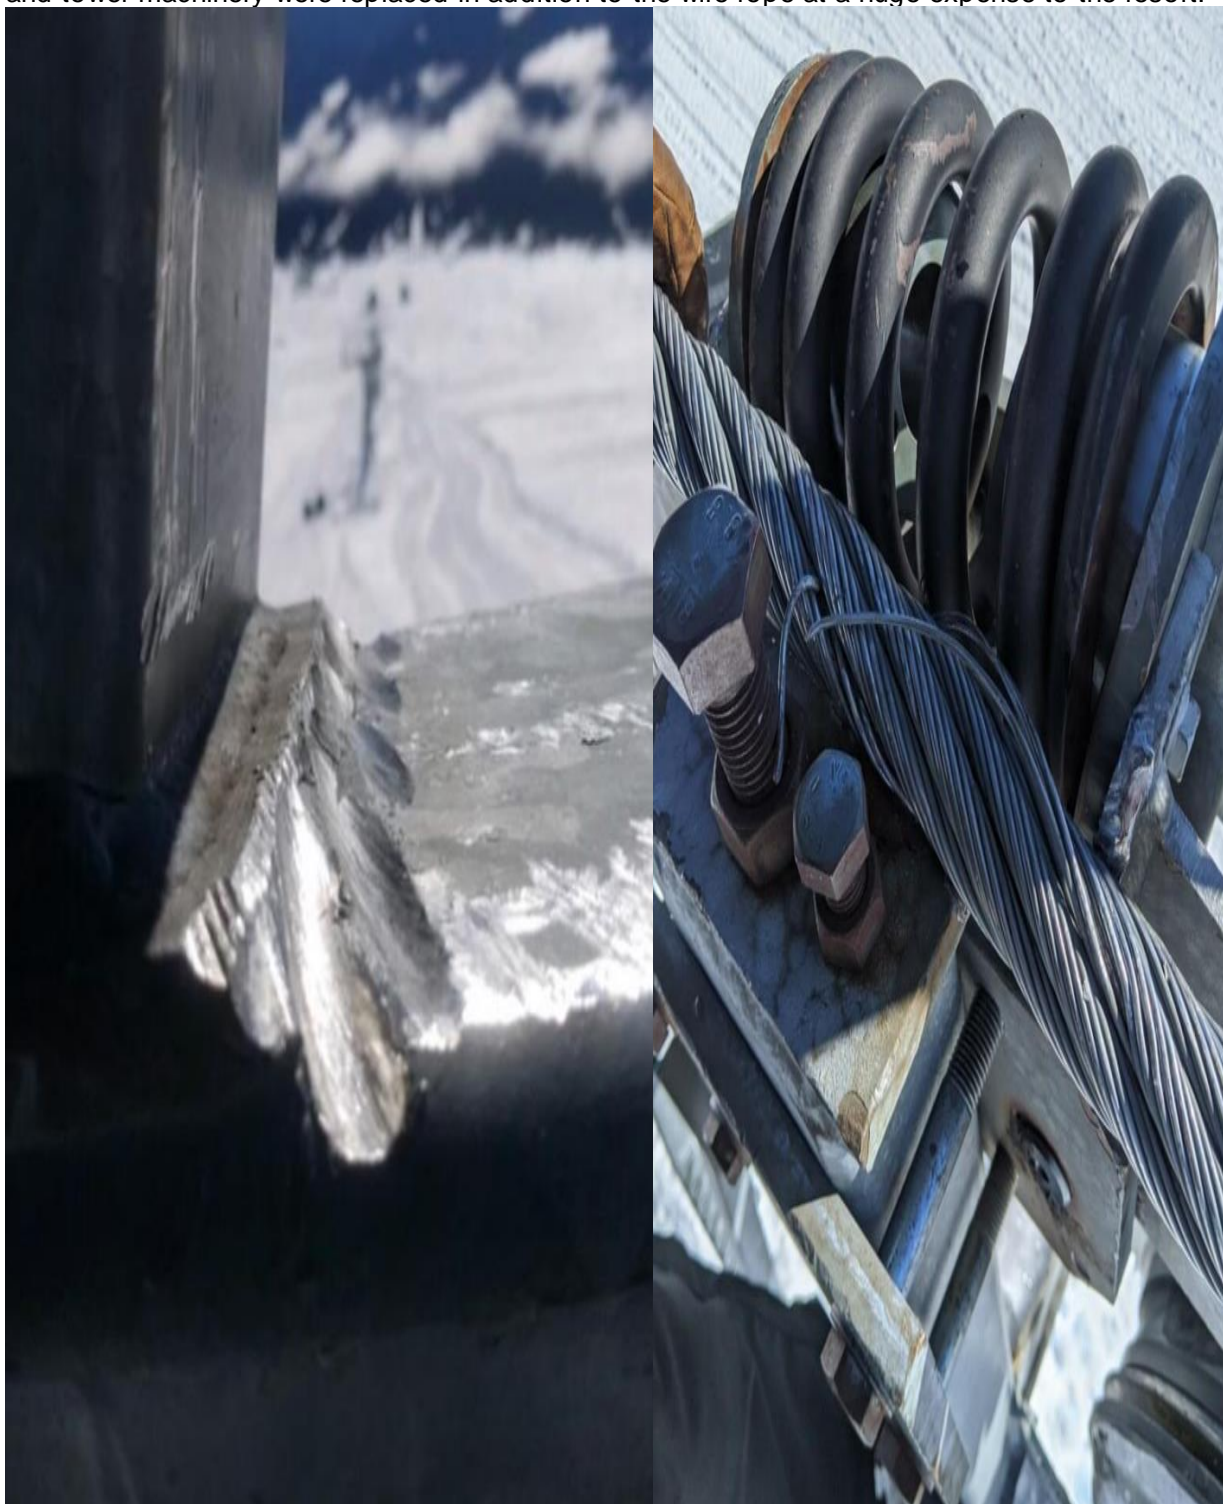
The haul rope's constant motion in the wind left its impression on the tower cross arm nearly 1/2" deep. Its destructive forces broke many wires in the haul rope as seen below. Multiple lifting frames, crossarms and tower machinery were replaced in addition to the wire rope at a huge expense to the resort.

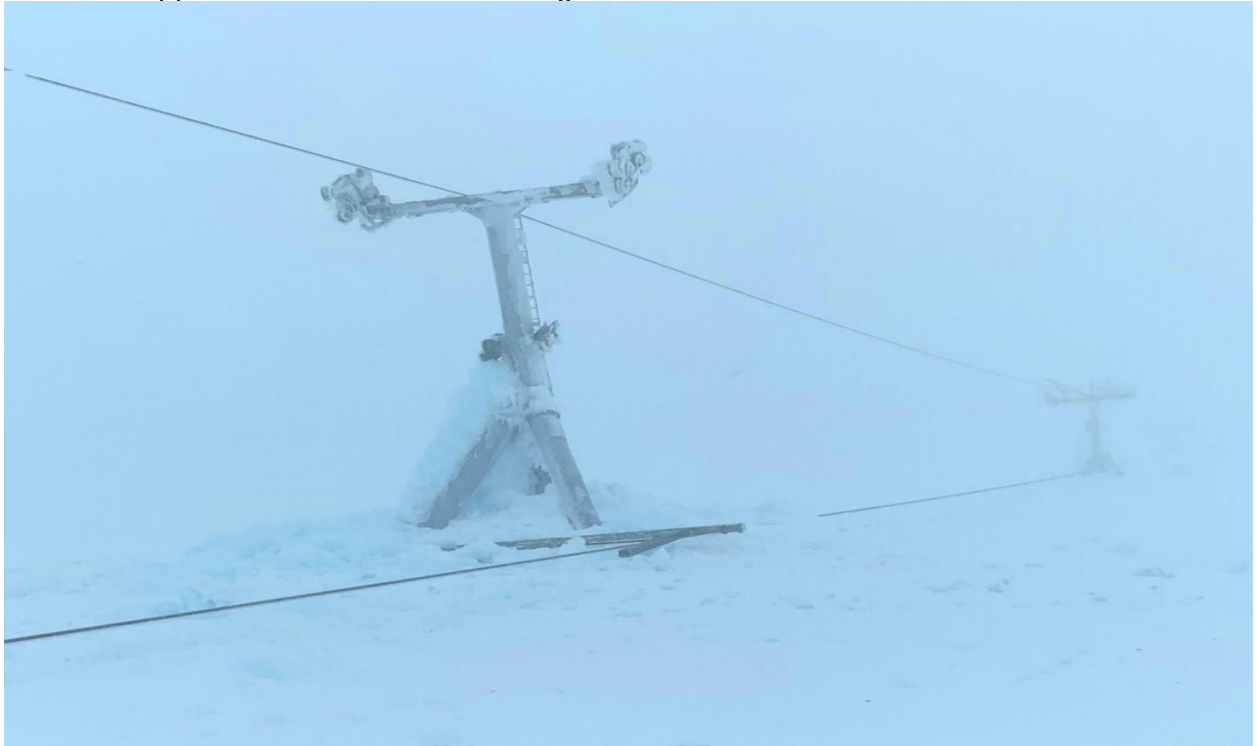
Cross arm ripped from tower and found on ground.

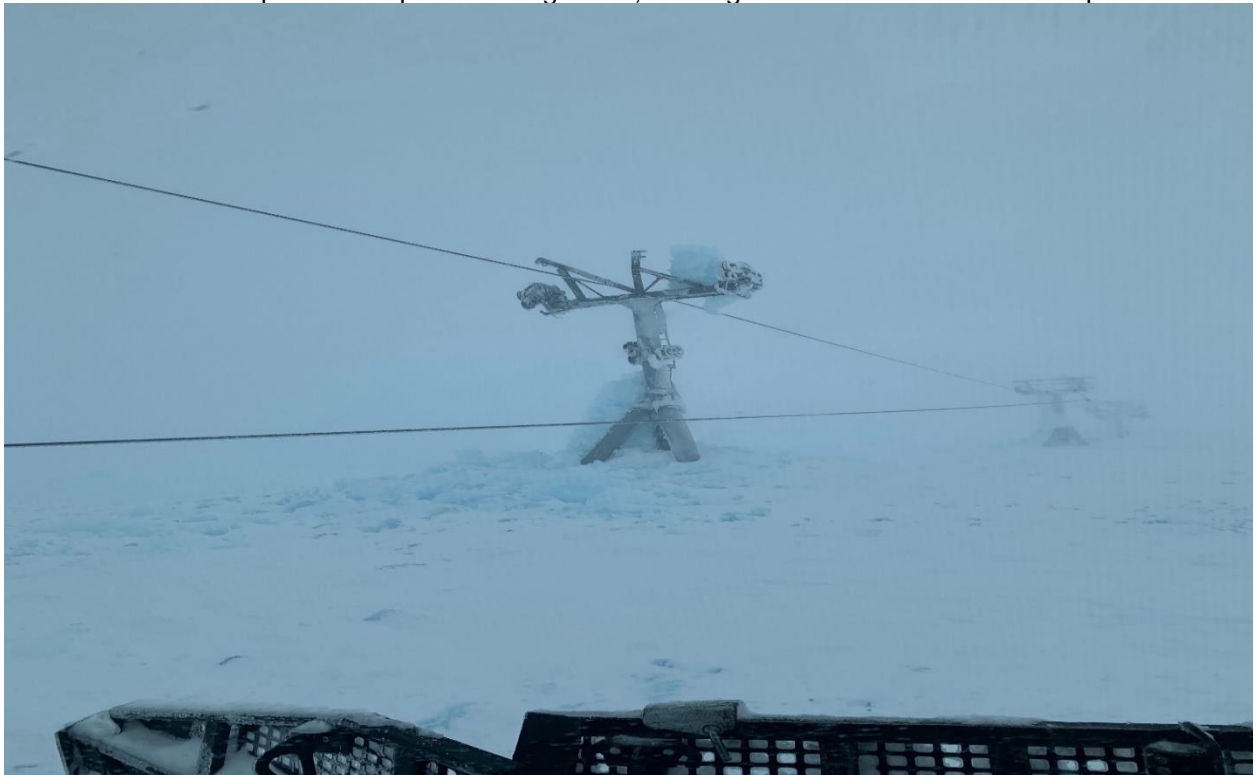
This tower had the rope fall on top of the lifting frame, causing it to buckle and lock the rope into itself.
